# Roaring Lion Fire - Assessment of Private Land Fuels Mitigation

Byron Bonney, Community Forester- Bitter Root RC&D

Visual assessment of hazardous fuels mitigation treatment following a wildfire event

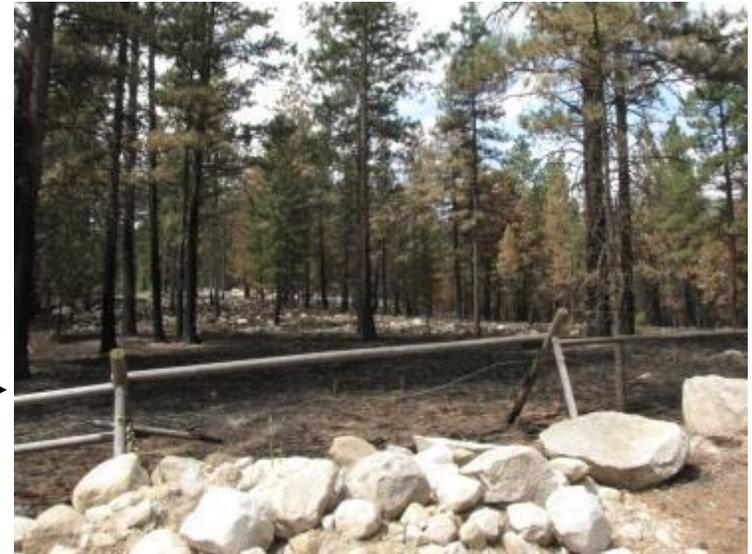
Fence line is the west property boundary between ownerships. The burned area beyond the fence was also treated. The surface fire and the shower of embers contributed to the fire burning all the equipment and garage/shop on the landowners property.

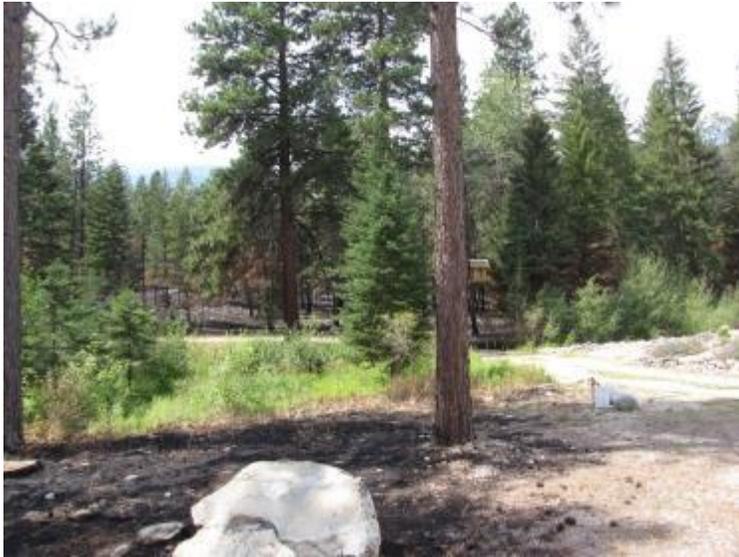
Riparian area south of house had minimal impacts from the fire.

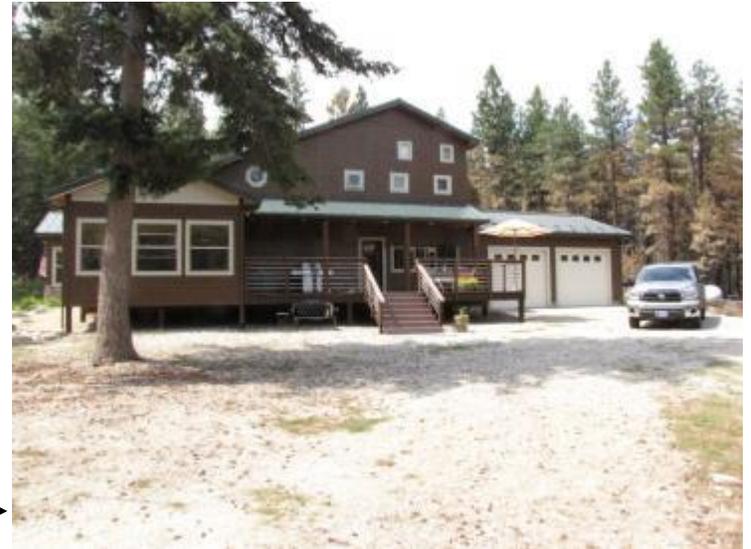
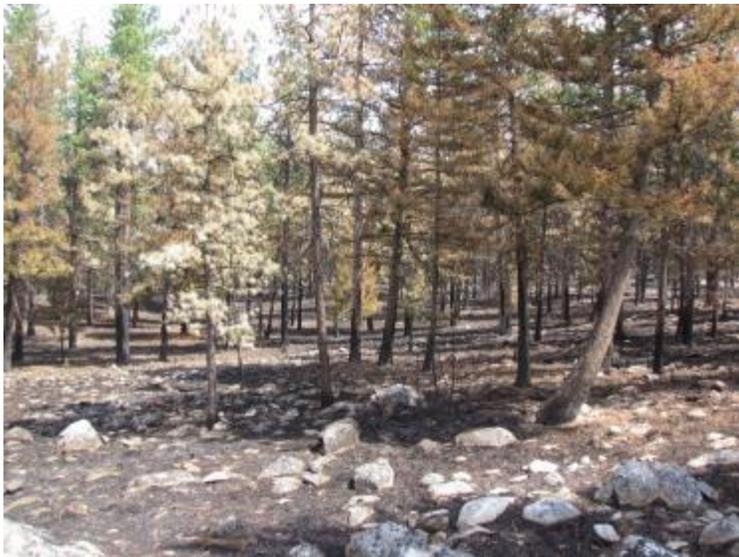
Residence was a model of a Firewise home. It did not have any burnable vegetation near or around the house. The deck had rock underneath the composite decking. It had a metal roof and cement board siding and a gravel driveway surrounded the house on two sides. Trees were cleared away from the house.

Timber stand north and east of the house where the surface fire burned across the property. Very minimal amount of torching but most of the Doug-fir had a significant amount of scorch.

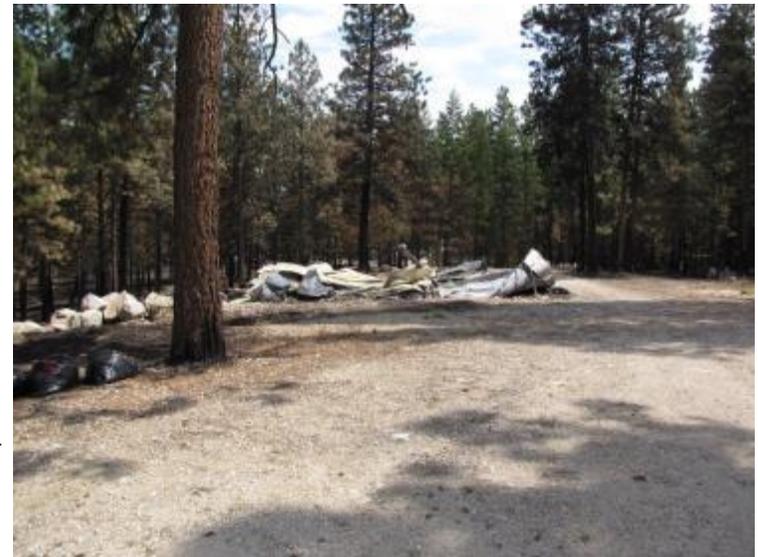
The site of the garage that was destroyed by the fire. It was about 200 feet east of the house. Ownership #1 property is about 500 feet behind the garage.

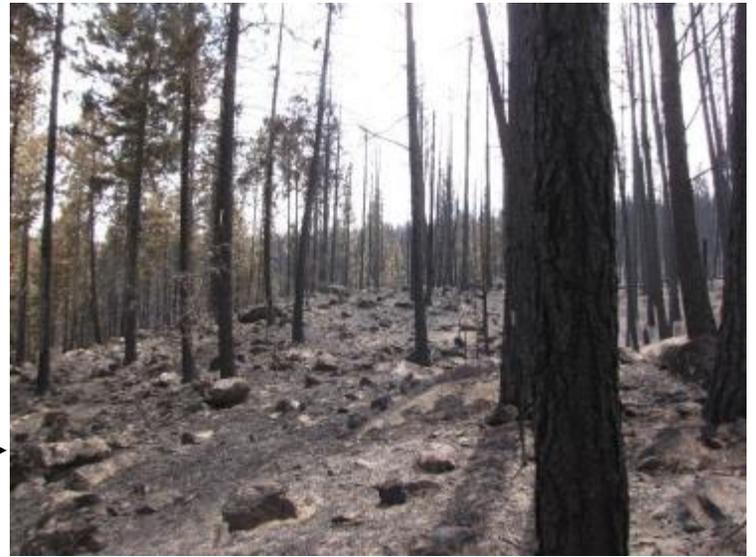
This area had a very intense active crown fire. It is located on the ridge to the SW of the landowner's house on the adjacent property. When the fire burned onto this property, it transitioned to a surface fire, underburning the thinned stand as shown below.

This is the stand to the east and below where the fire entered this property. The Doug-fir had a significant amount of scorch from the superheated air passing through the stand that was produced by the crown fire to the west.

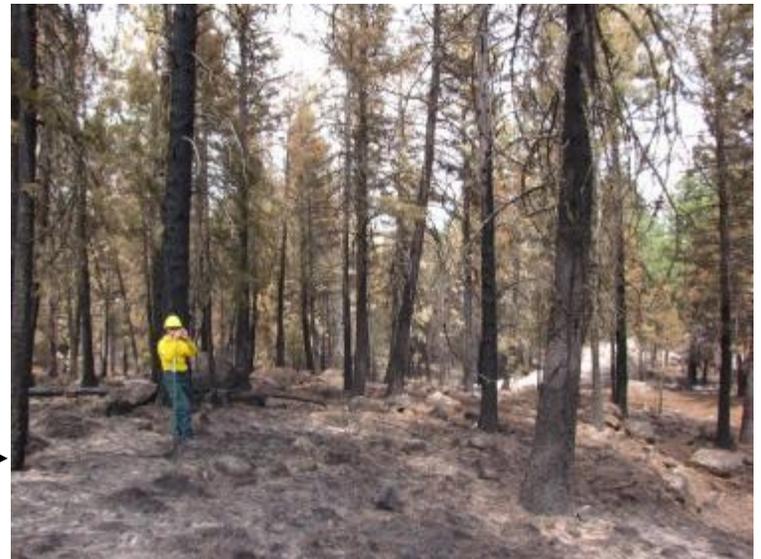
This is on the ridge to the west of the landowners house looked north toward the Roaring Lion Road.

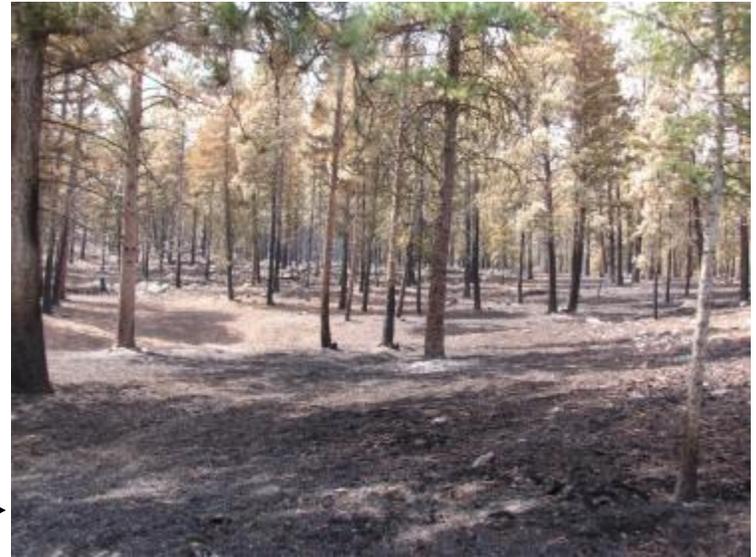
This area had very high scorch damage to the surrounding timber on the property. This area is north of the house location.

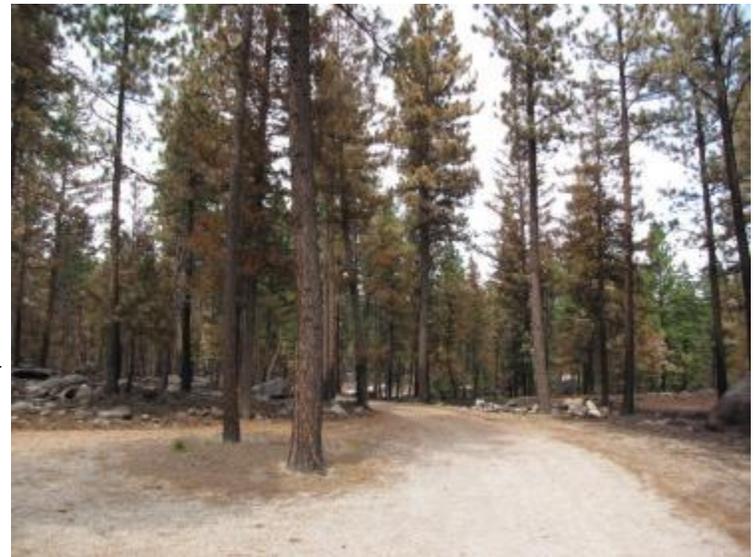
This area had very high scorch damage to the surrounding timber on the property. This area is north of the house location.

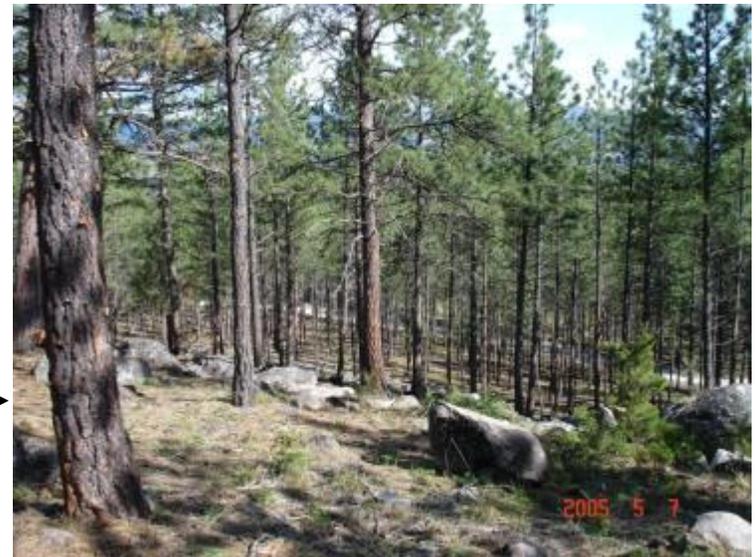
This area is north of the house showing the property after the thinning. The Judd Creek Hollow Road is in the center of the photo through the thinned stand.

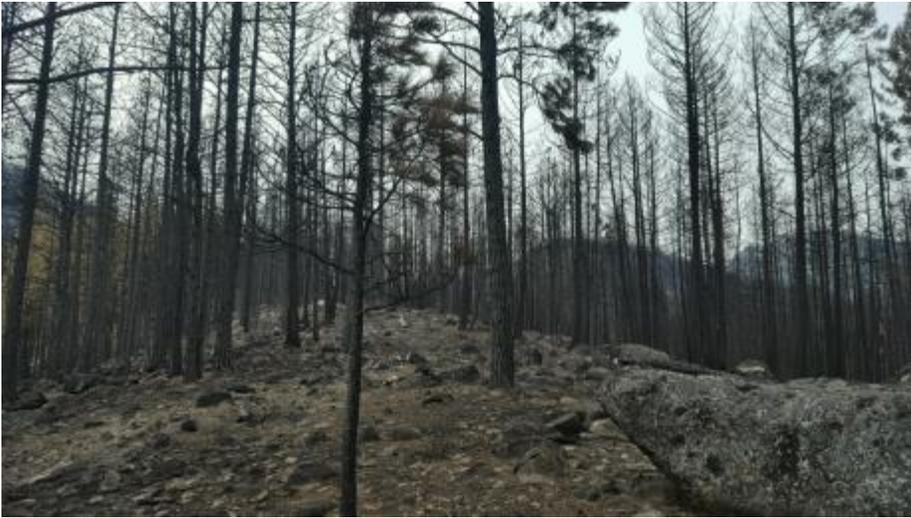
**#1 – Upper Left Photo** – Un-thinned area directly adjacent to property (thinned in 2005). This area was totally consumed by a high intensity crown fire.

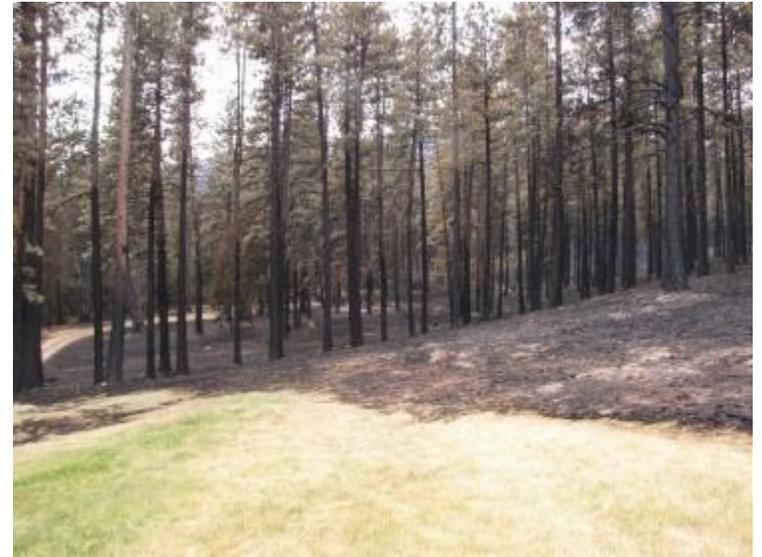
This area had very high scorch damage to the surrounding timber near the house. This area is SW of the house.

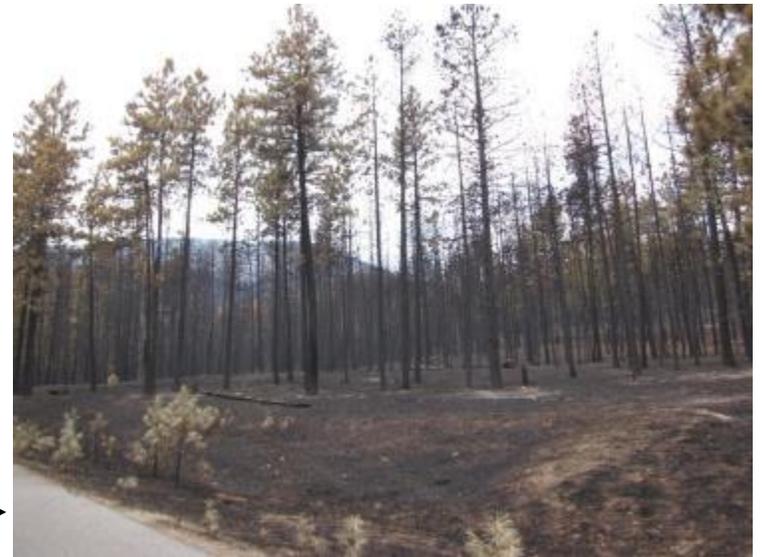
This area was across the Judd Creek road from Ownership #5 property showing active crown fire and torching that impacted this property. This area shows the crown fire run to the north of Ownership #6 secondary residence that was lost in the fire.

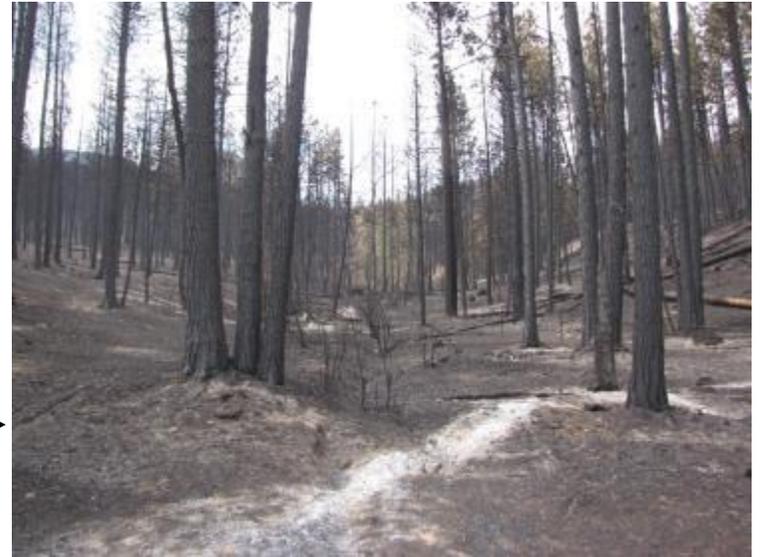
This area had very high intensity crown fire burning the entire riparian area to the north of the residence location. This view is looking from the Judd Creek Hollow road to the west toward NF system land. →

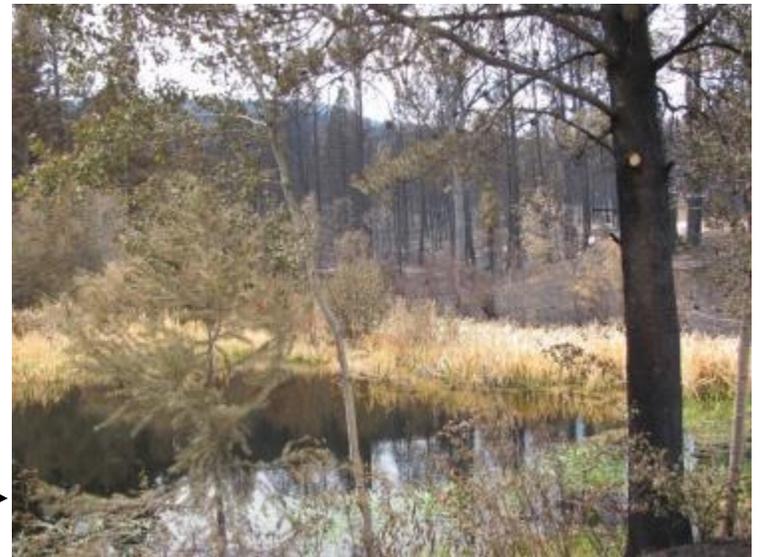
Pond adjacent to the Judd Creek Hollow road on this property. Note that all of the cattails turned brown due to the superheated air from the intense crown fire. →

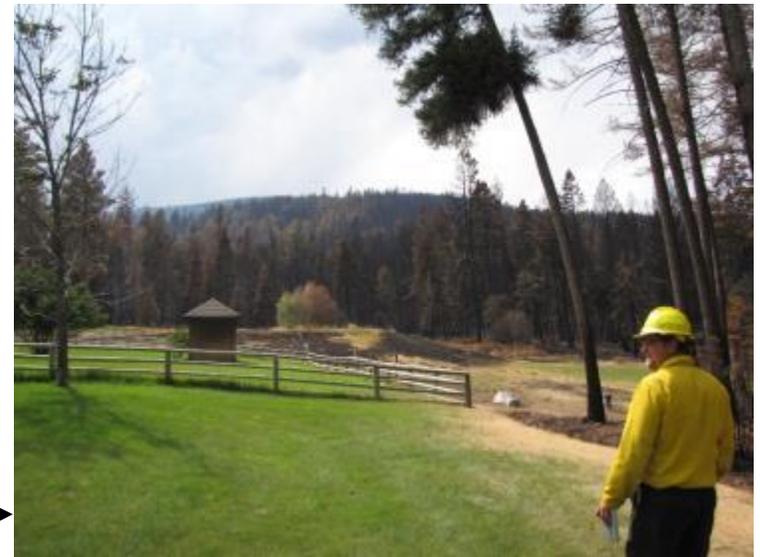
Looking from the primary residence to the west across the large open area. The main fire burned from west to east. The area where the intense crown fire burned the secondary residence is to the right in this photo. Note the deciduous tree in the center of the photo that was scorched on the right side. This was due to that intense crown fire.

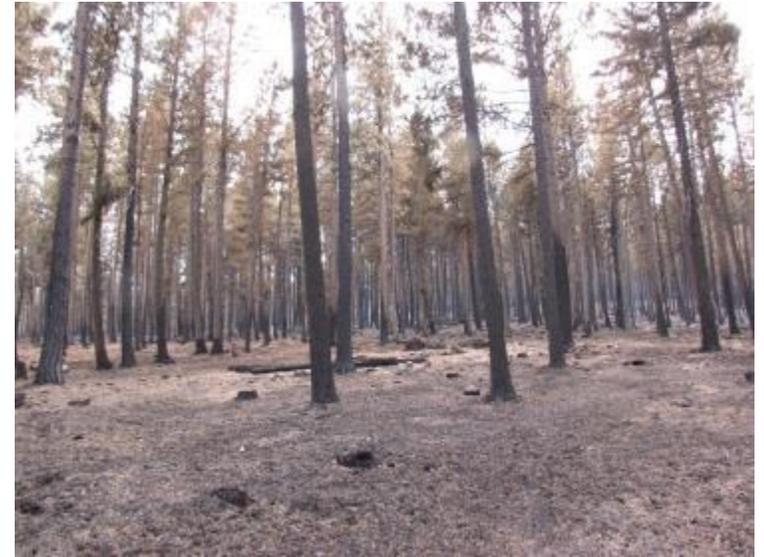
This area had high intensity surface fire burning through the thinned stand. Very little evidence of torching and no evidence of high intensity crown fire but there is group torching and active crown fire on the adjacent property to the west (Ownership #10).

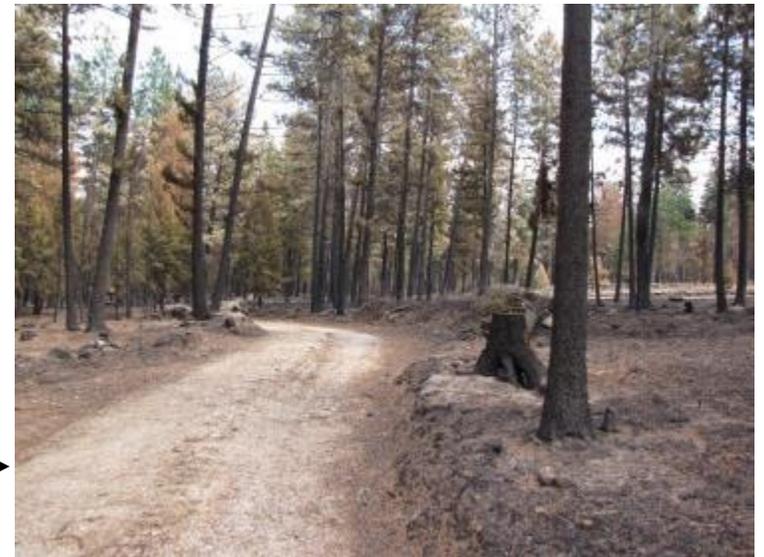
The access road from the main Judd Creek Hollow road to this owners residence also leading to Ownerships #9 & #10 properties. This access is one way in and one way out.

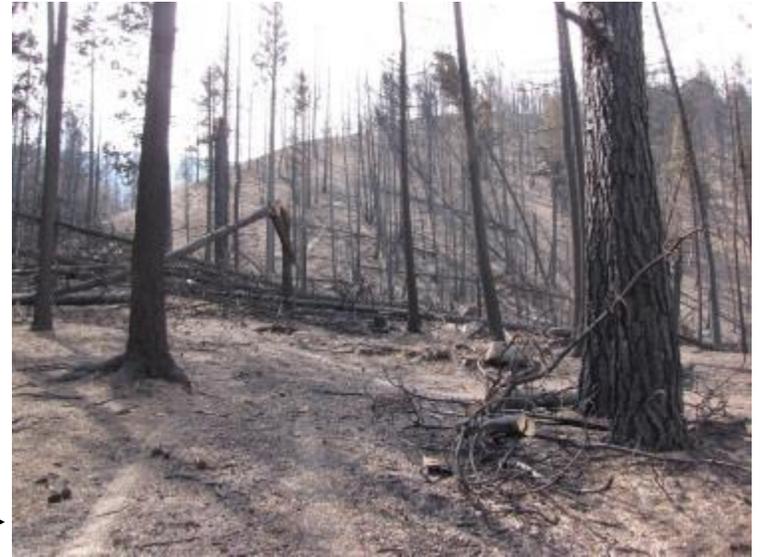
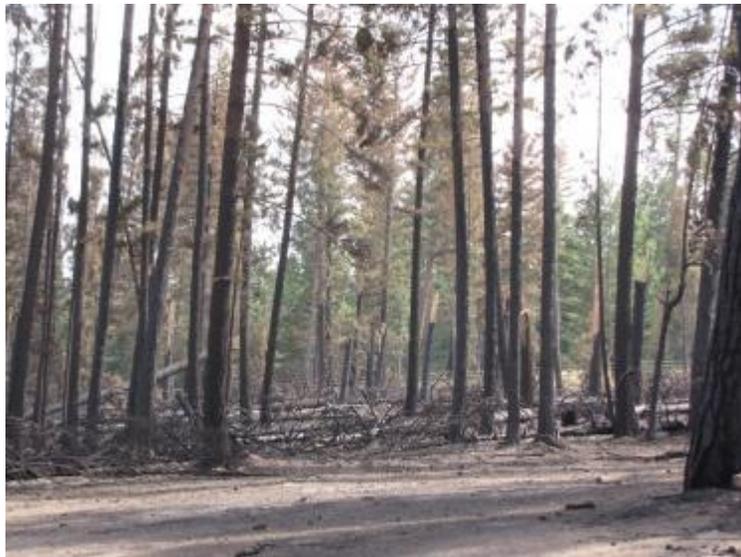
← This area shows the intense crown fire that burned through the upper portions of landowners property. Note the broken tree in the center is the same tree on the right side of the photo on the left. →

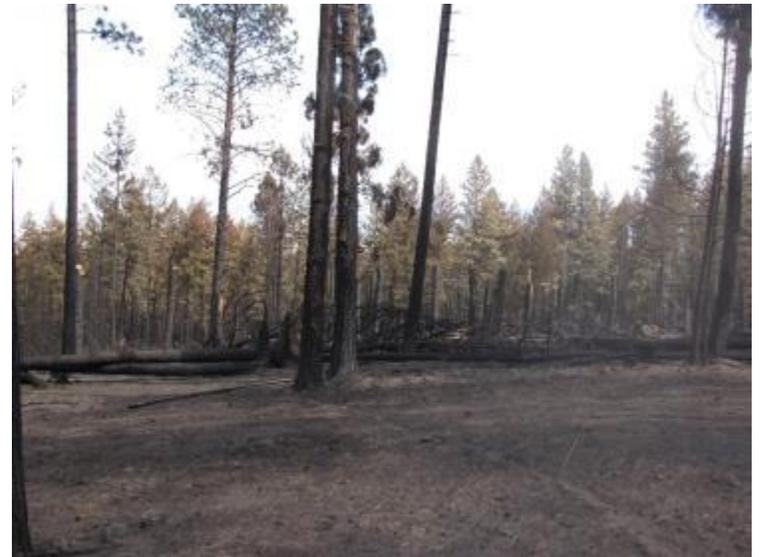
Area on and adjacent to landowner's property where the wind from the fire uprooted and broke off trees. This area is below to the SE of where landowner's residence was located. Part of this stand is on Iten's property.

← Another view through the thinned area on landowner's property of the uprooted and broken off trees. →

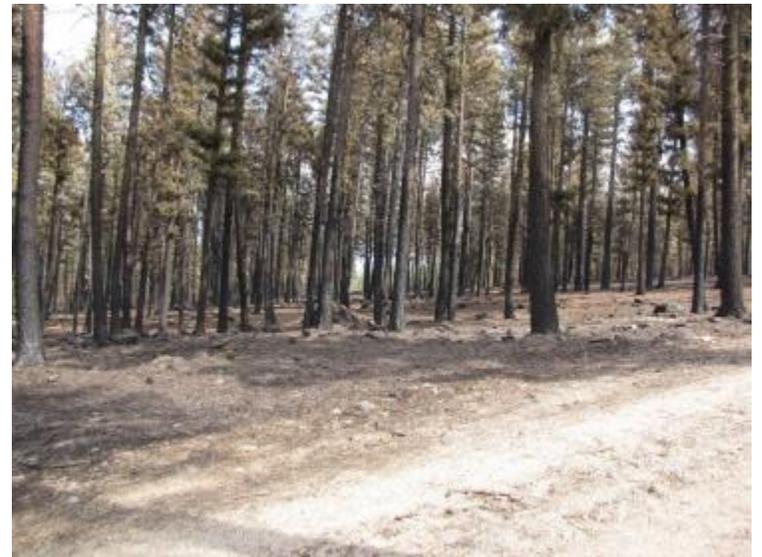
This area shows the area across the road from landowner's property on Rukusak's property that supported a surface fire but very little, if any evidence of any fire in the crowns. The road to Ownership #9 & #10 is one way in and one way out. →

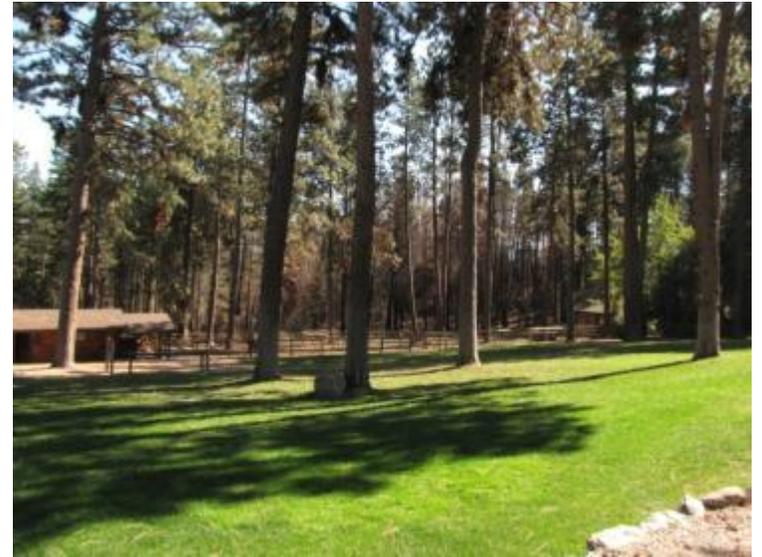
This area shows the area to the east of the residence that did not receive any damage from the fire.

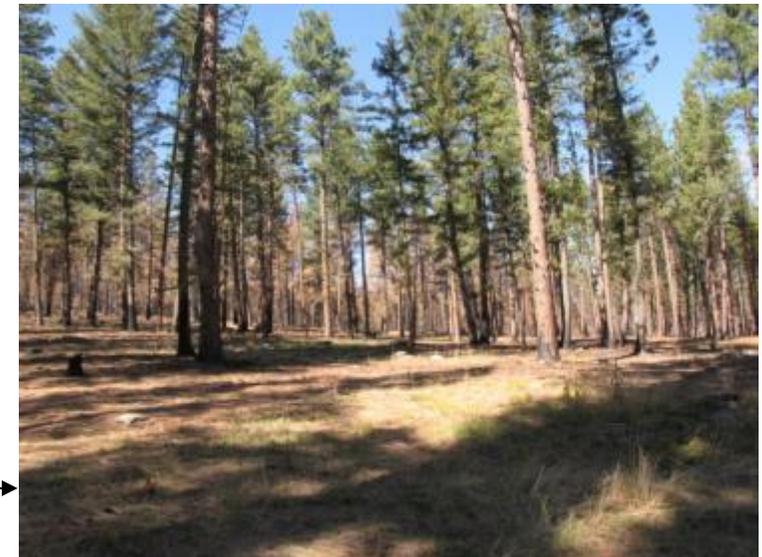
← Looking toward the east of her home and north of the corrals, the wind from the fire was so intense that it broke some large Ponderosa Pine trees about 20-30 feet up from the base. Notice that most of the remaining trees did not receive much scorch.

This photo shows where the fire underburned the thinned stand of larger Ponderosa pine trees but there was very little scorch. The fire was a surface fire with virtually no torching in this stand.

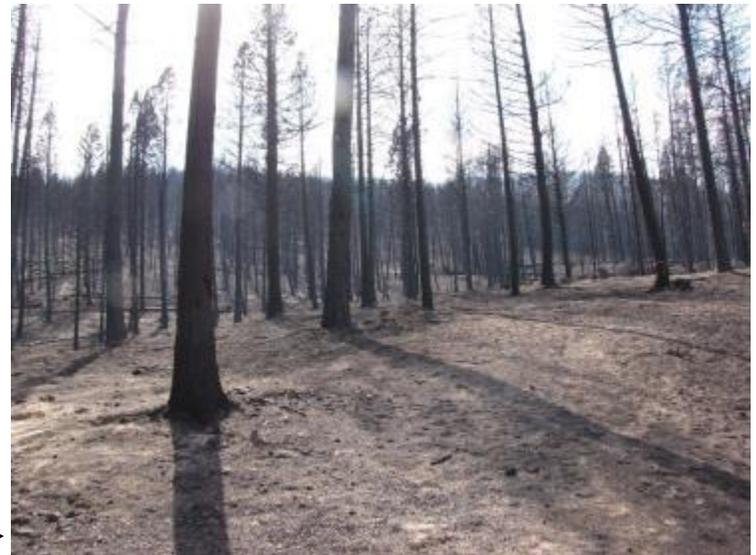
This photo shows the effects of the intense crown fire to the west of the house above the opening shown in the photo on the left.

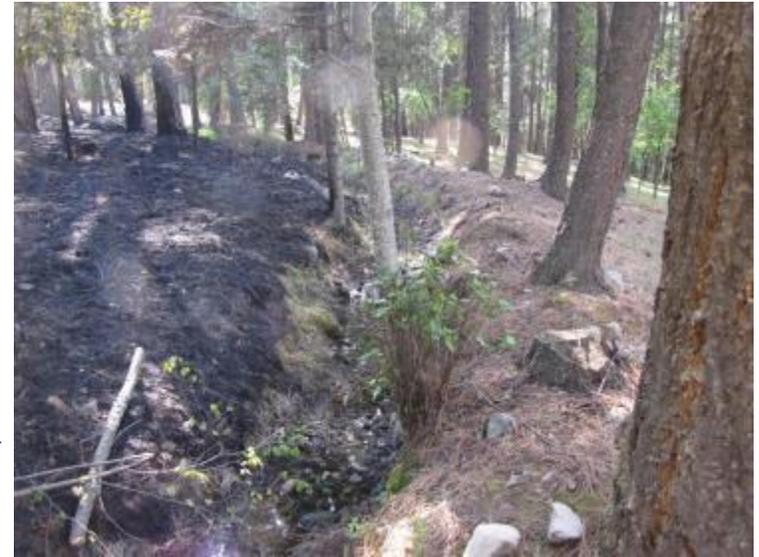
This photo shows the irrigation ditch that kept the fire from spreading to the home. →

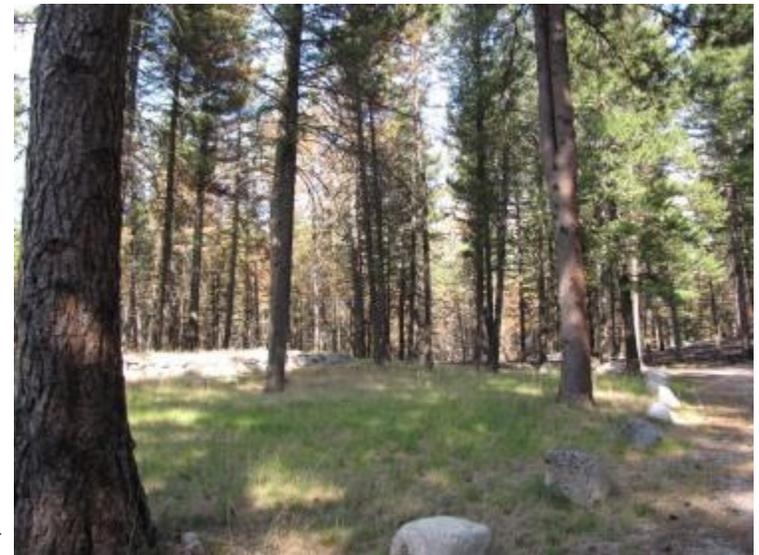
This photo shows the area near the secondary home that was not impacted by the fire in this thinned stand. The fire did spot to the east of this property causing some torching and a fairly intense surface fire that burned toward Ownership #1 & #2 properties to the east. →

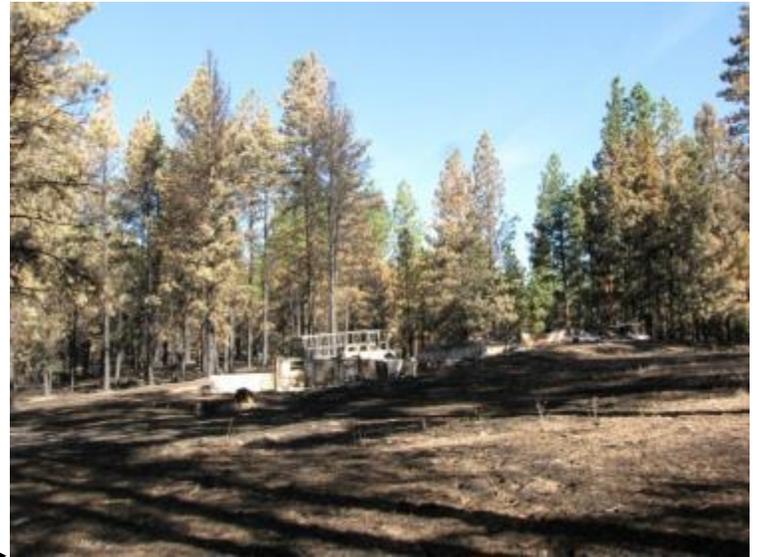
This landowner's neighbor lost their home from a shower of embers and surface fire. This property was not thinned and the house had a shake roof, wood siding, pine needles on the roof and burnable shrubs around the

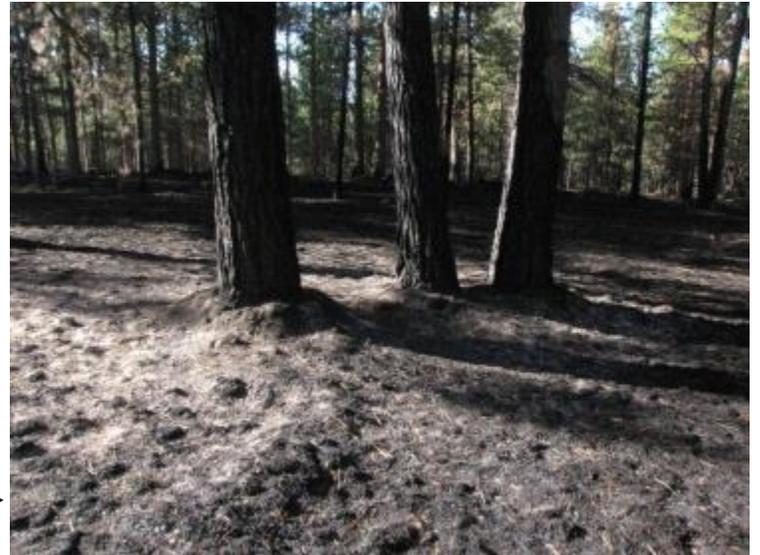
The surface fire burning around some of the older Ponderosa Pine trees. It remains to be seen as to the severity of this fire to the root systems of these trees due to the deep needle litter layer surrounding them.

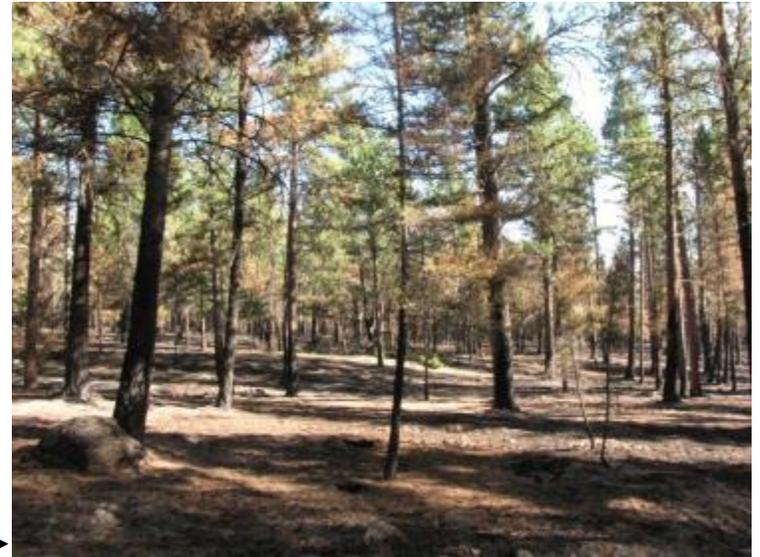
The property was being thinned at the time of the fire by a contractor. This stand was one of the areas that had been thinned and had minimal scorch to the Ponderosa Pine trees.

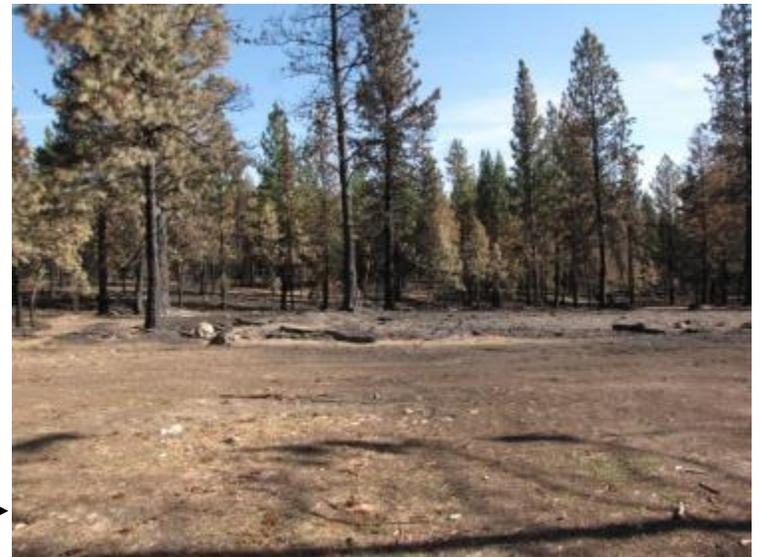
This is the area where the contractor lost 10 loads of logs/pulp due to the fire that were harvested off the thinning project. The trees that were severely scorched and/or had their crowns torched were as a result of the burning log deck close by.

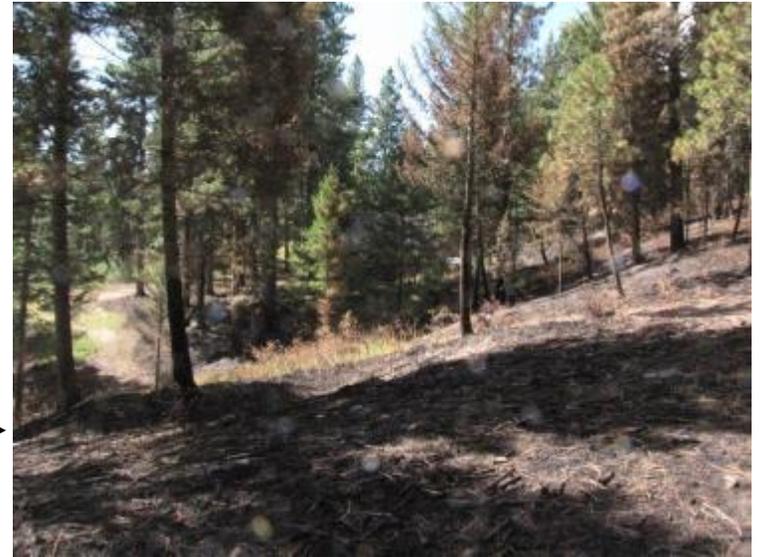
The area behind the fence did not burn even though there was an active crown fire in the background on NF land because this was a mule corral that had very little vegetation and very few trees. The area in the foreground was a surface fire that burned toward the barn. \_\_\_\_\_<

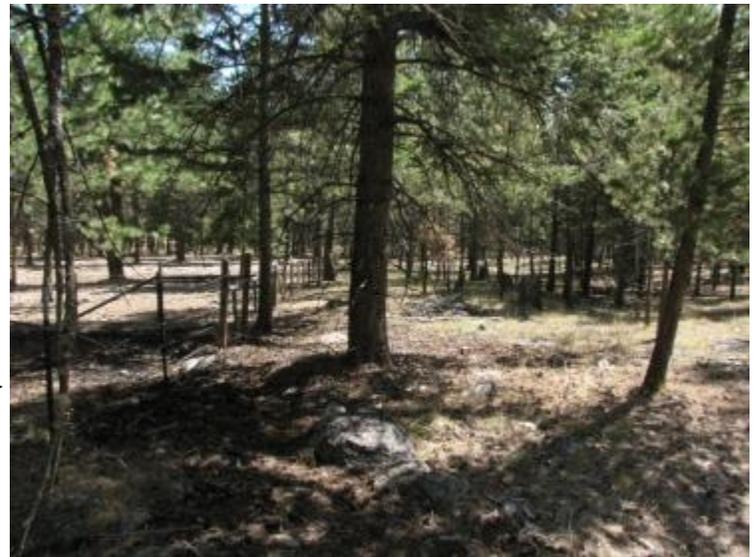
Same area where the surface fire burned but did not scorch any of the trees. Many of these trees were Doug-fir.

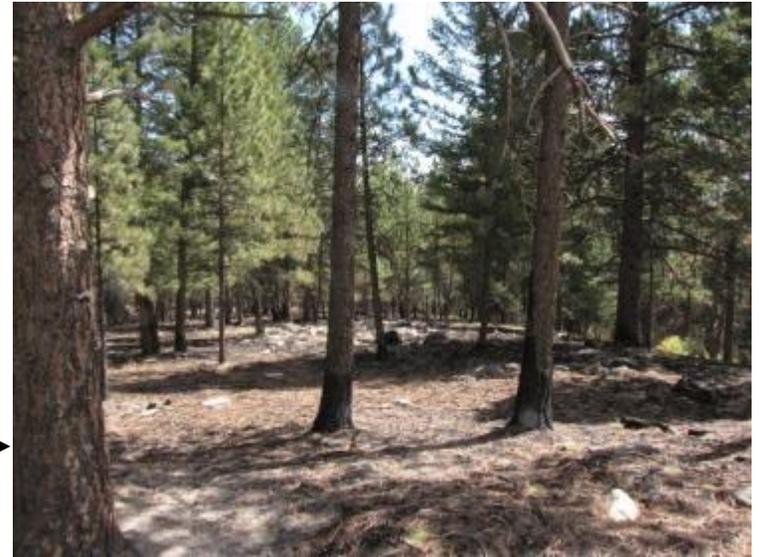
This is a photo of the thinned area north of the house and the draw. The fire did not burn into this area due to the lack of fuels and probably due to the wind conditions that were not spreading the fire in that direction. The adjacent property to the north of this area had an intense crown fire and torching which probably drew any fire spreading in the surface fuels by in-drafts away from this area.

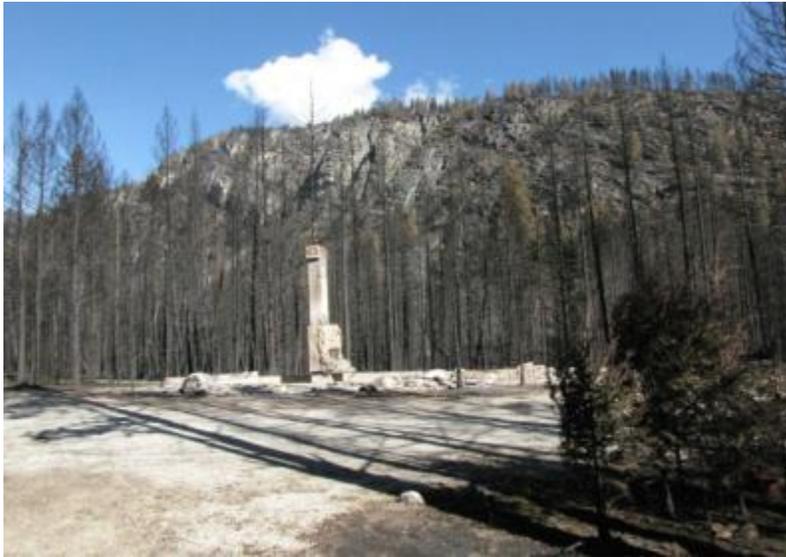
Photo of the main house on this property that was destroyed by the fire. The fire burned the entire rock face in the background and spread into Sawtooth Creek, the next drainage to the north of Roaring Lion Creek.

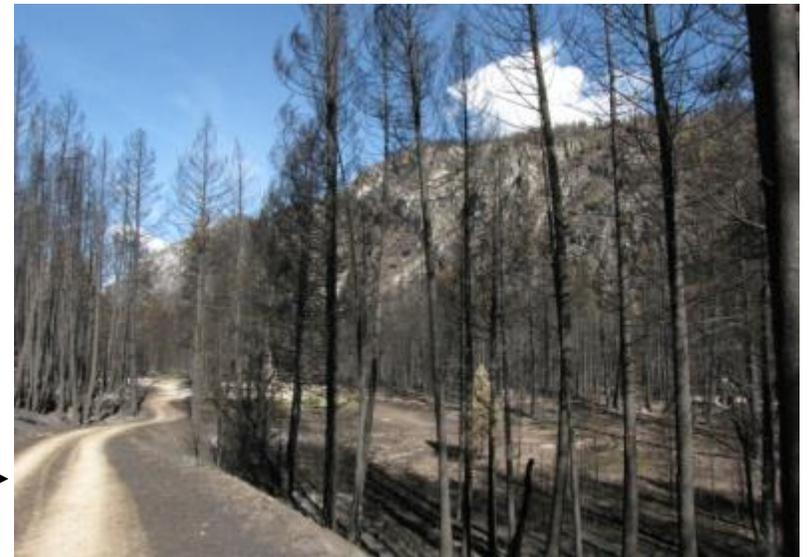
Looking SW across the Roaring Lion trailhead road through landowner's property to National Forest. Total stand replacement active crown fire.
