# Roaring Lion Fire - Assessment of Private Land Fuels Mitigation

Byron Bonney, Community Forester- Bitter Root RC&D

Visual assessment of hazardous fuels mitigation treatment following a wildfire event

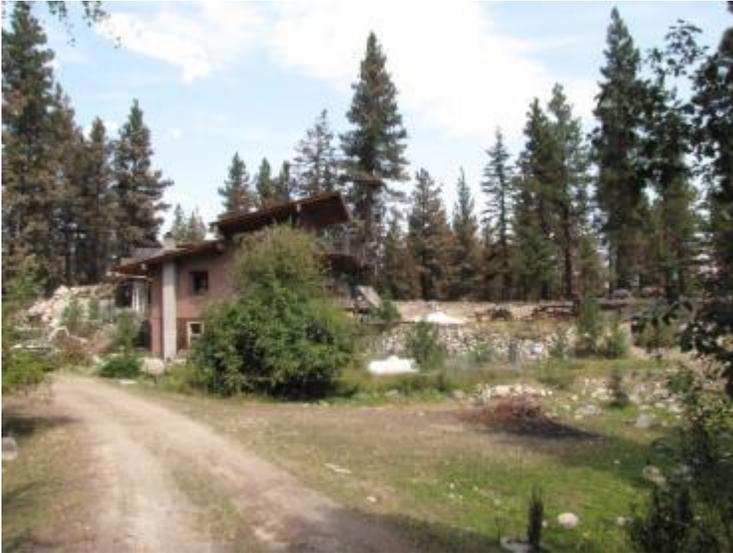
Residence was protected by landowner before leaving the area by using 350 gallons from his water truck. The garage/shop behind the house was totally destroyed. It was only about 40 feet from the house.

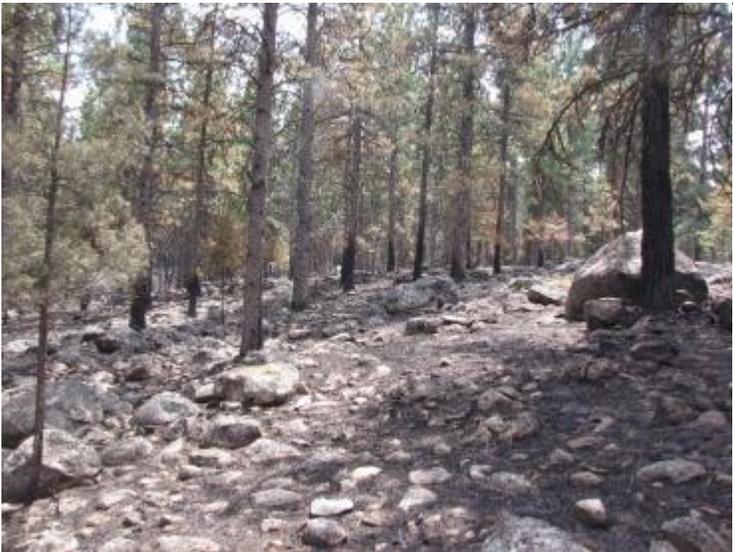
Fence line is the west property boundary between ownerships. The burned area beyond the fence was also treated. The surface fire and the shower of embers contributed to the fire burning all the equipment and garage/shop on the landowners property.

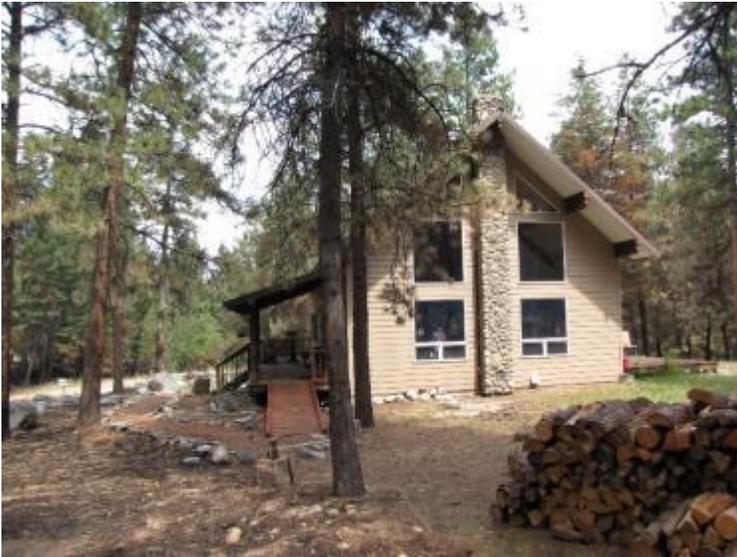
Residence was not damaged by the fire but the surface fire did burn up to the pathway in front of the house.

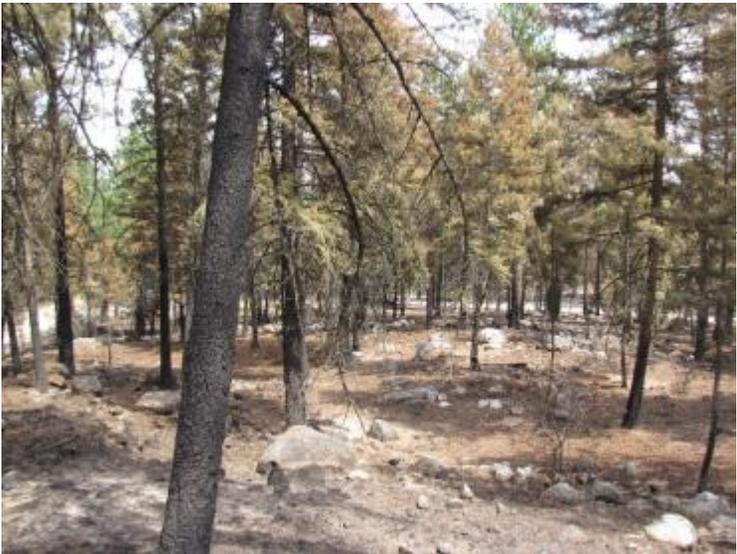
This is the stand to the east and below where the fire entered this property. The Doug-fir had a significant amount of scorch from the superheated air passing through the stand that was produced by the crown fire to the west.

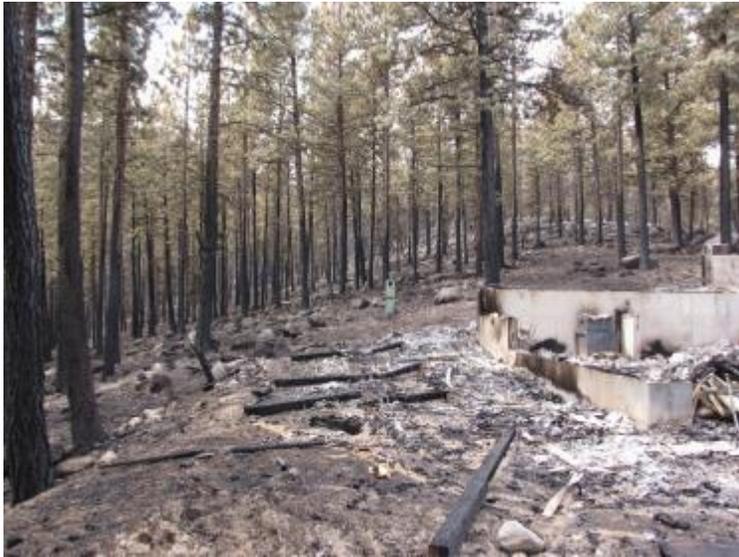
Ownership #4 house foundation that was destroyed by the fire. Due to the lack of torched trees or crown fire, it is evident that the house burned as a result of an ember shower and surface fire with superheated air from the intense crown fire west of the property.

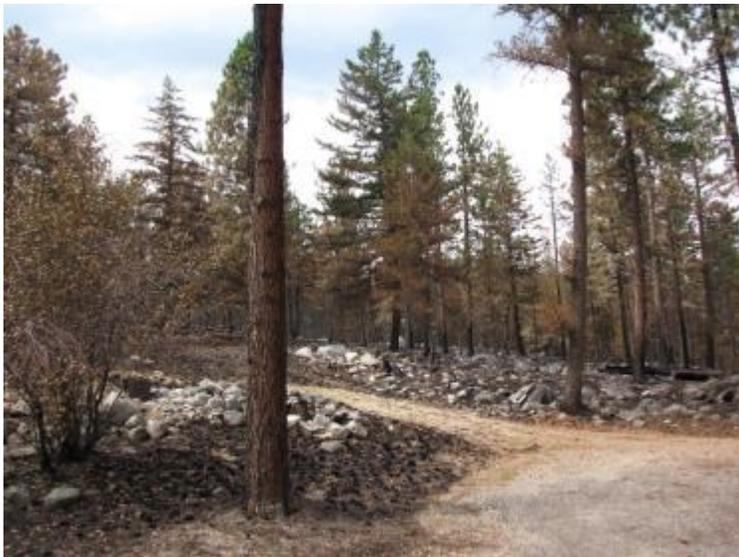
Area near the house location showing the surface fire and crown scorch.

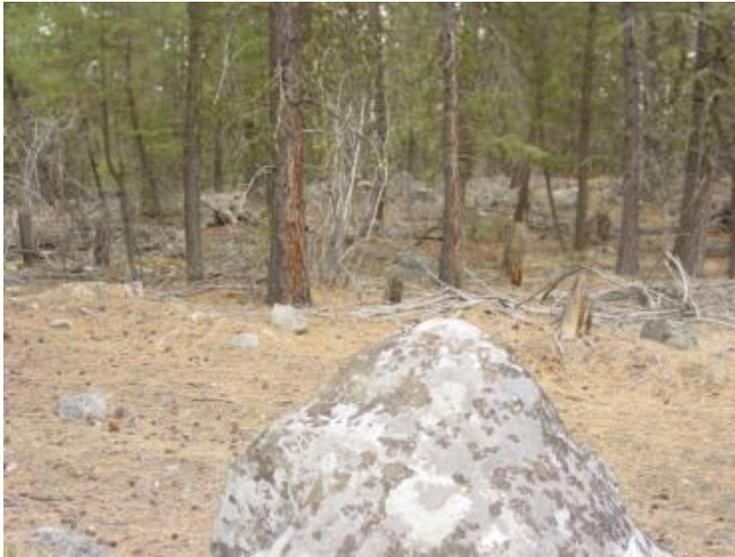
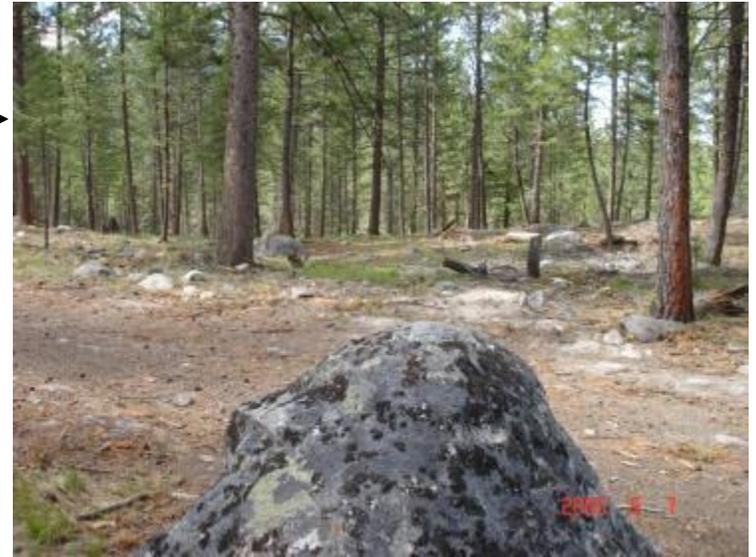
These two photos show before and after the thinning that took place on Ownership #4 property.

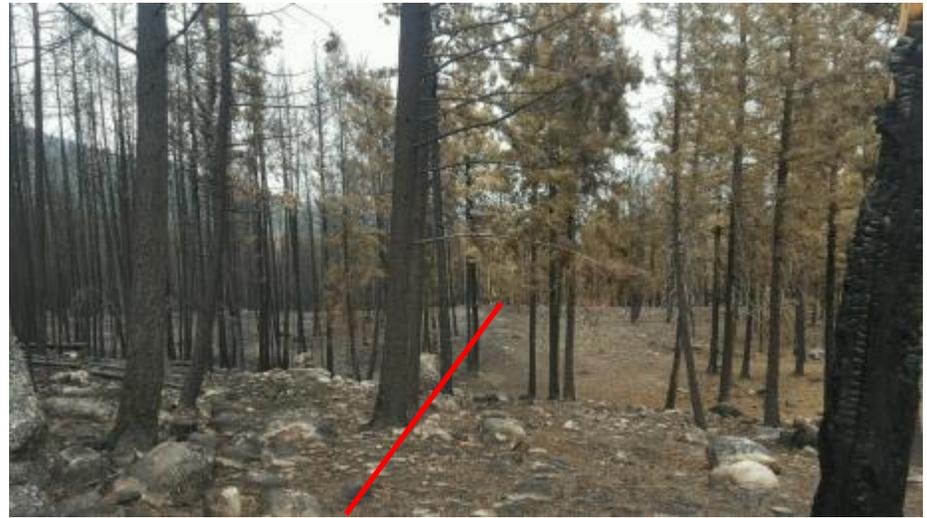
**#1 – Upper Left Photo** – Un-thinned area directly adjacent to property (thinned in 2005). This area was totally consumed by a high intensity crown fire.

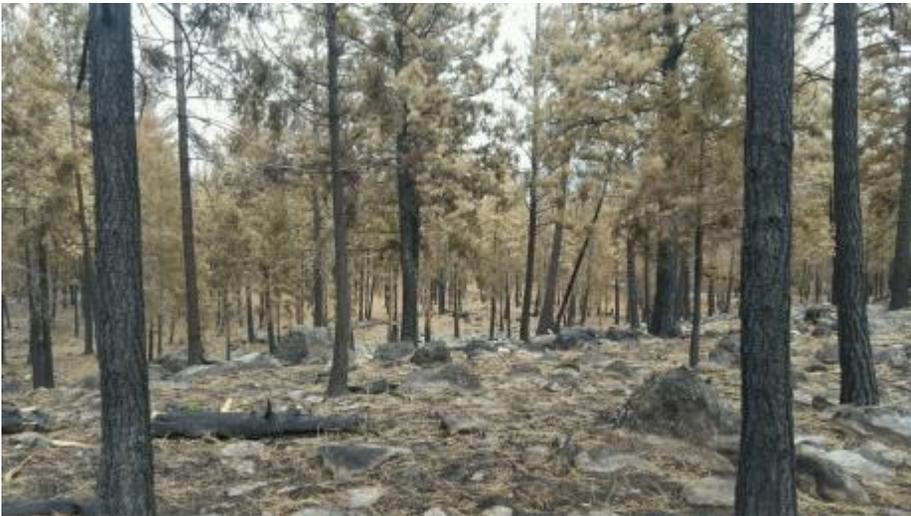
**#2 – Upper Right Photo** – The stark contrast between the un-thinned adjacent stand of timber to the thinned stand of timber on Ownership #4 property. The approximate property line is shown as the red line.

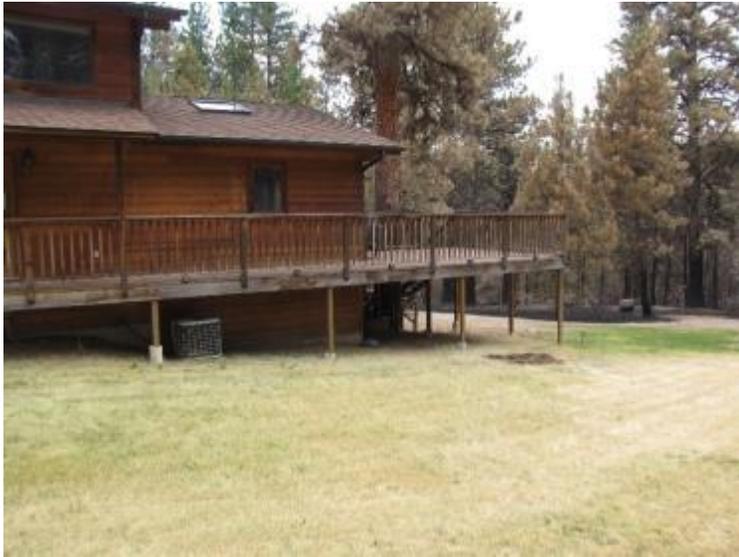
Ownership #5 house that survived the fire. Due to the lack of torched trees or crown fire, it is evident that the area around the house burned as a result of a surface fire, spotting from ember showers with superheated air passing through the timber stand west of the house from a crown fire across the Judd Creek road. Note the spot fire burned area to the right of center below the deck.

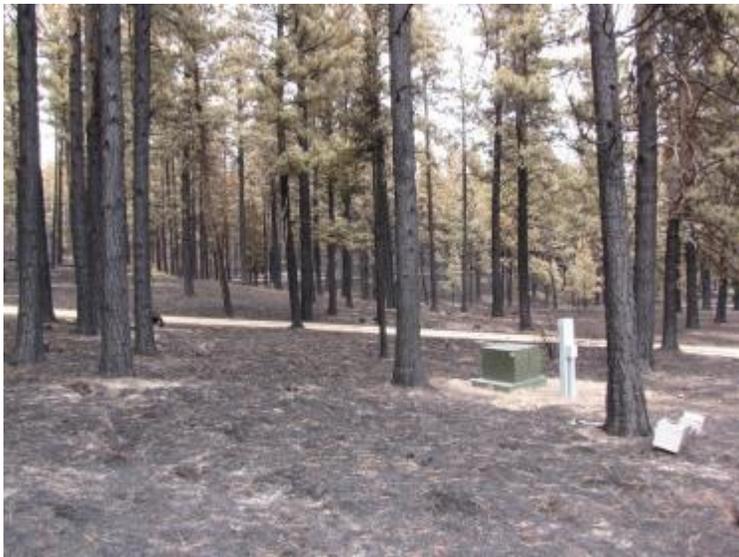
Area north of the house where the surface fire burned through the timber stand showing a high amount of scorch with no torching or crown fire activity.

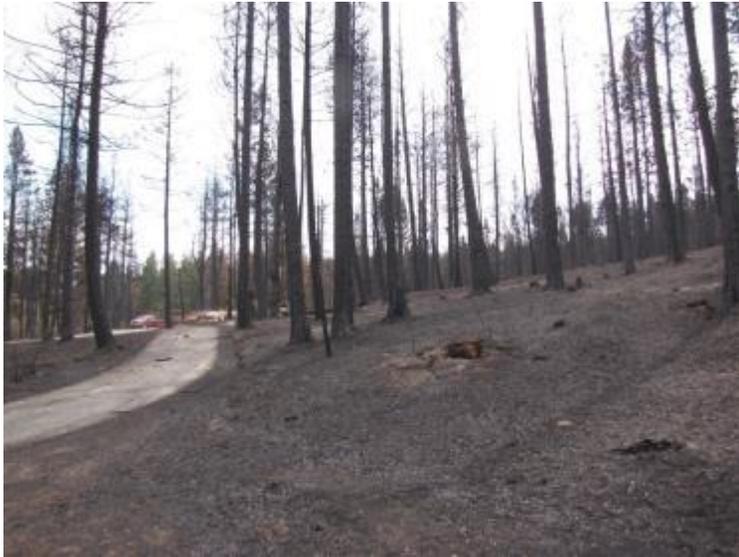
View of Ownership #7 secondary residence that was destroyed by the fire by a high intensity crown fire. ←

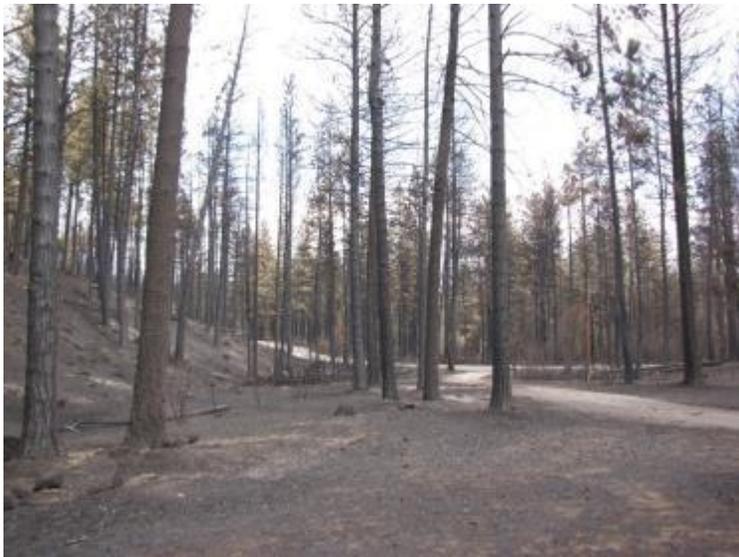
Effects of the high intensity crown fire burning through Ownership #7 property toward Ownership #5 property. Judd Creek Hollow road is in the middle ground in the photo. Photo is looking east. ←

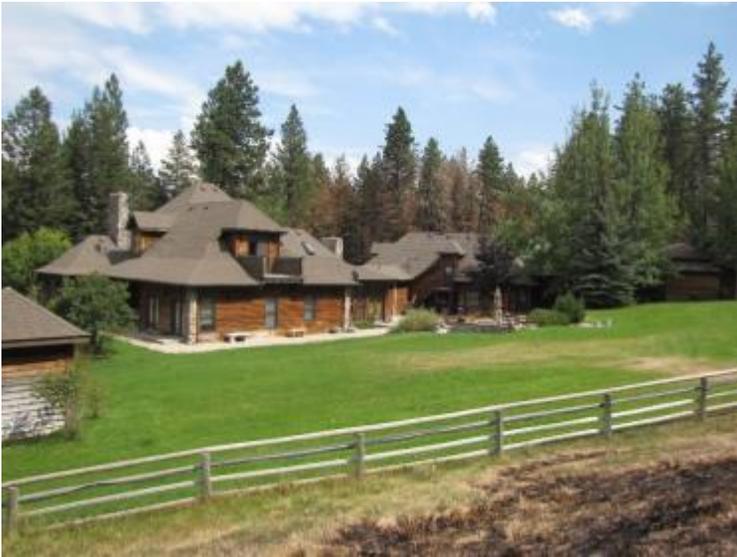
View of Ownership #7 primary residence that survived a high intensity crown fire that passed to the north of the residence. This house survived partly due to the large open area to the west of the house which was the direction of fire spread.

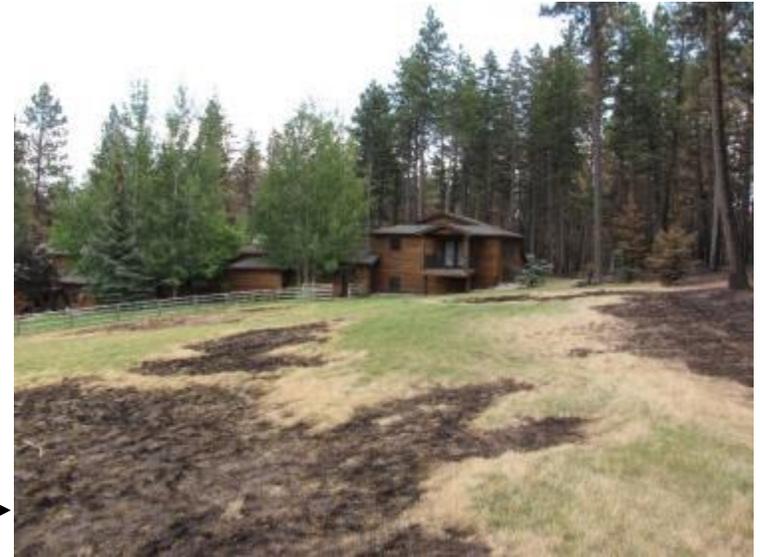
The southern section of the primary residence that also survived the fire. There was surface fire and most probably ember showers that started several spot fires around the area.

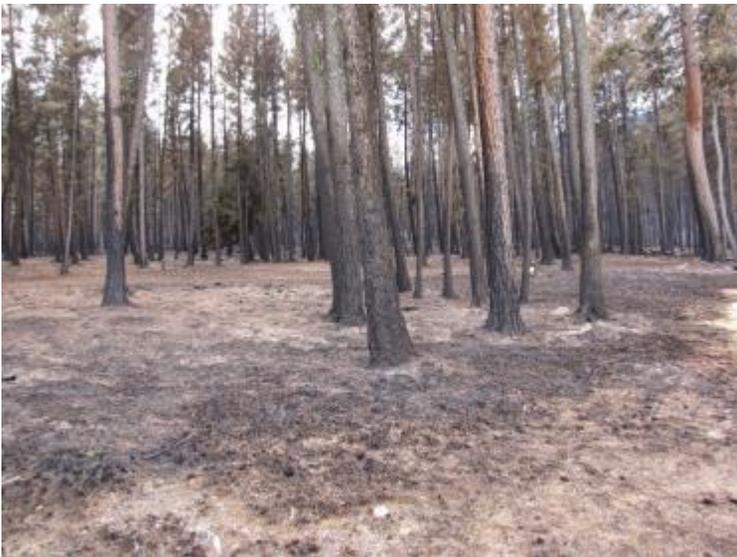
Timber stand W/SW of the primary residence that was thinned. Effects from the fire were intense surface fire but minimal torching and no active crown fire.

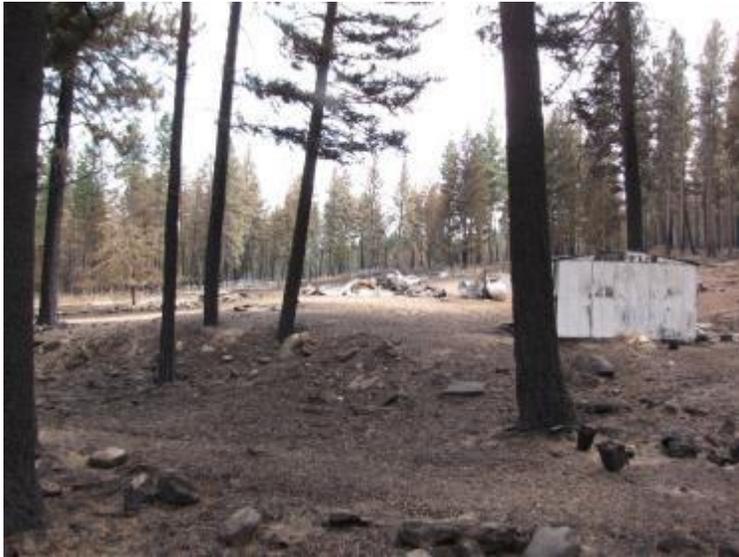
View of Ownership #8 residence that was destroyed by the fire. It is a high probability that this residence was destroyed by an ember shower landing on receptive fuels on and around the house. No evidence of high intensity crown fire or torching near the home.

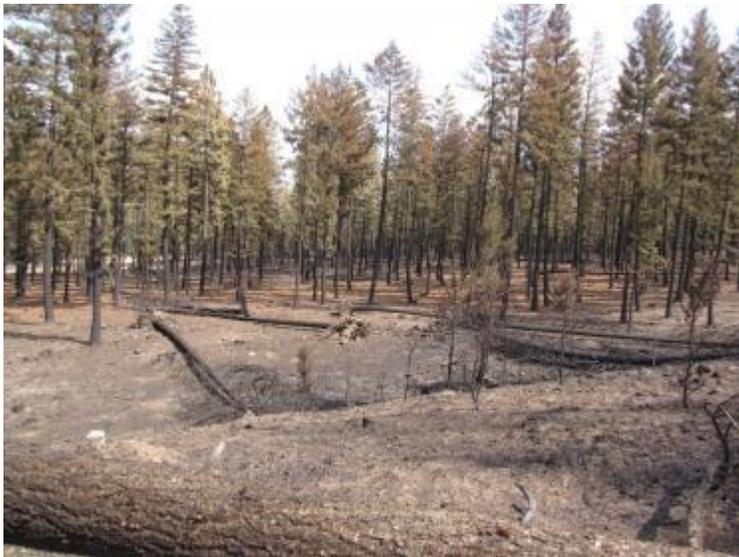
Area between this residence and Judd Creek Hollow road that was open. This area supported active surface fire with a moderate amount of scorch in the timber. It is evident that this opening assisted in reducing the damage to the downwind timber stand in the photo.

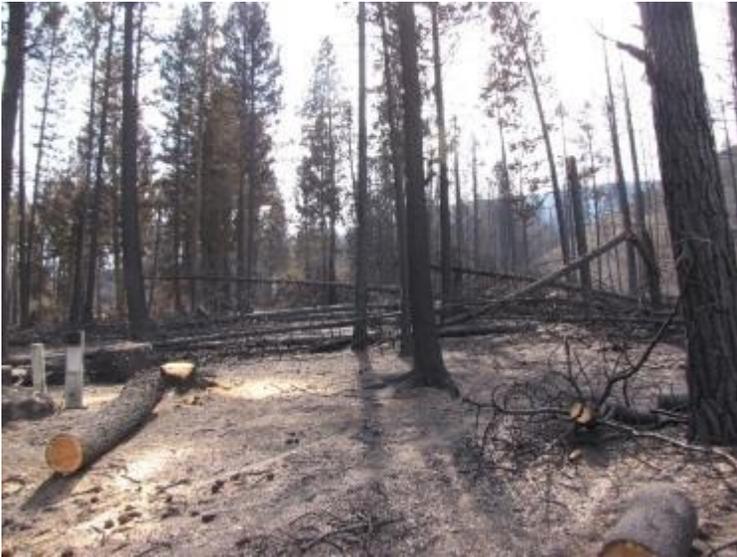
Road to owners residence was blocked by uprooted and broken off trees. Landowner's house did not survive the fire. His house was located directly behind the trees that are across the road. Notice that the intense crown fire burned through this area from National Forest that is directly adjacent to his property.

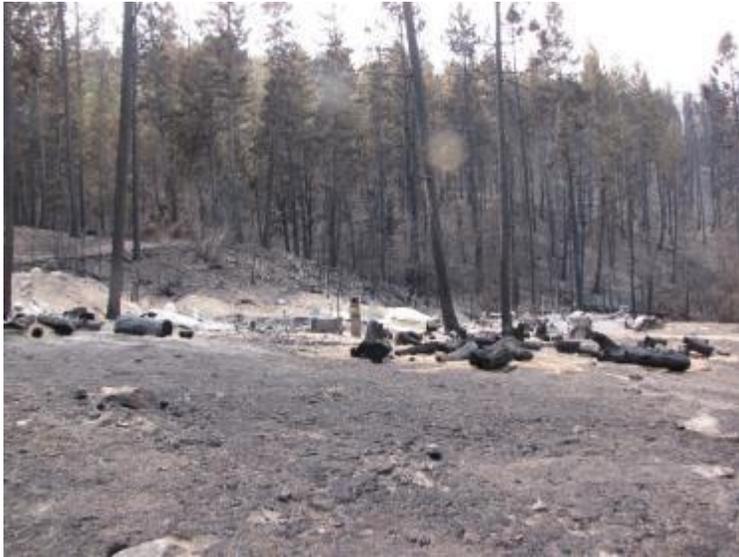
Area where landowner's residence was located directly adjacent to the National Forest. Area around residence was thinned. ←

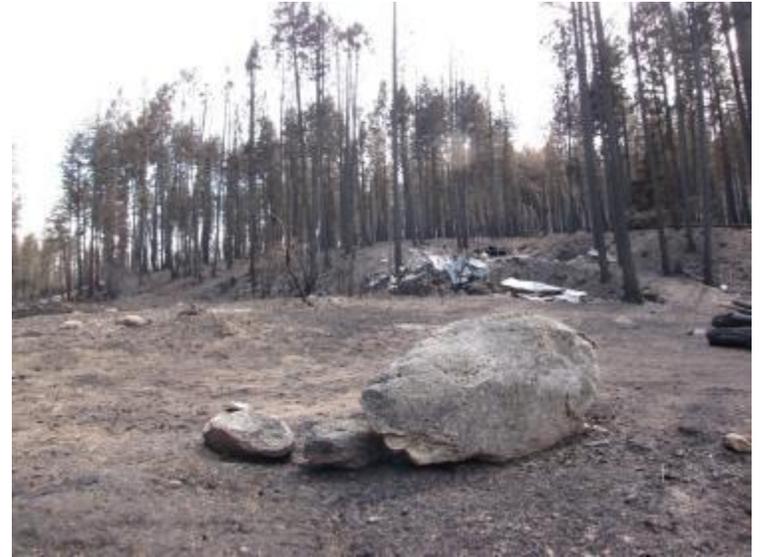
Looking down the road leading to the Judd Creek Hollow road toward an area that shows an intense crown fire north of landowner's residence. ←

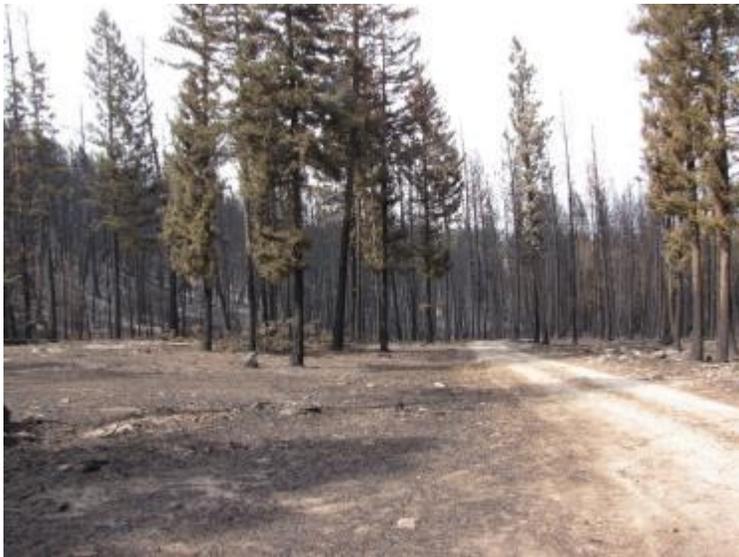
This area shows the area across the road from landowner's property on Rukusak's property that supported a surface fire but very little, if any evidence of any fire in the crowns. The road to Ownership #9 & #10 is one way in and one way out. →

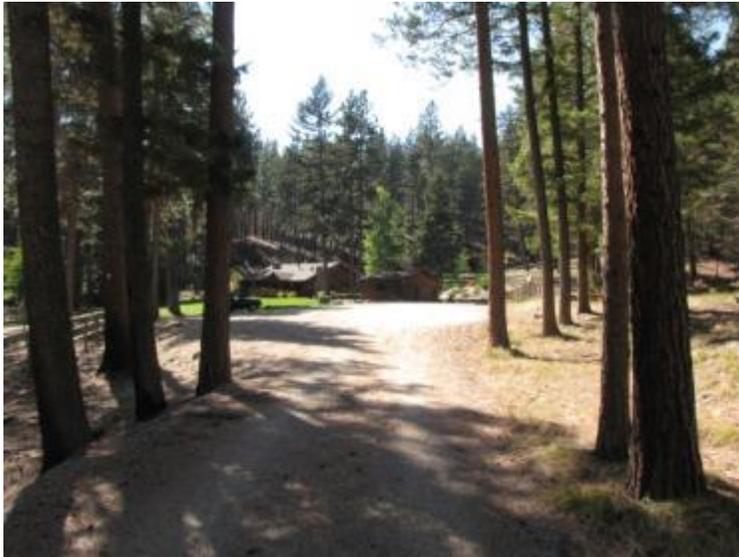
← Landowner residence after the fire. Due to the open and thinned areas around the home and outbuildings, the structures survived.

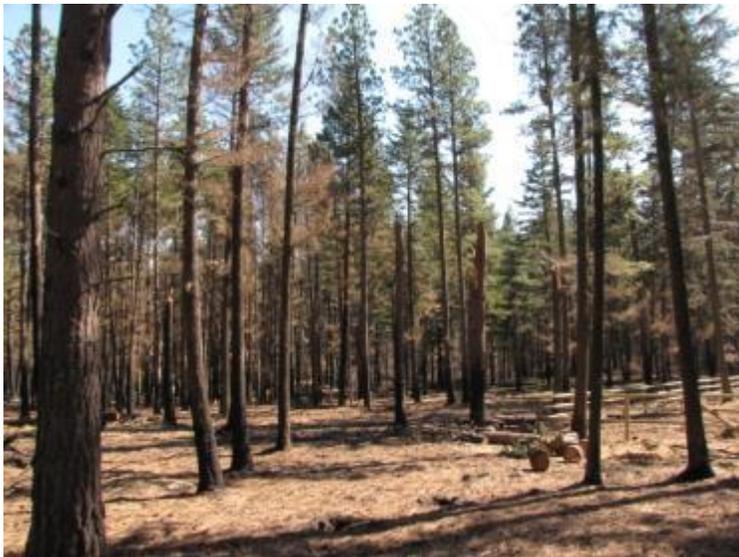
← Looking toward the east of her home and north of the corrals, the wind from the fire was so intense that it broke some large Ponderosa Pine trees about 20-30 feet up from the base. Notice that most of the remaining trees did not receive much scorch.

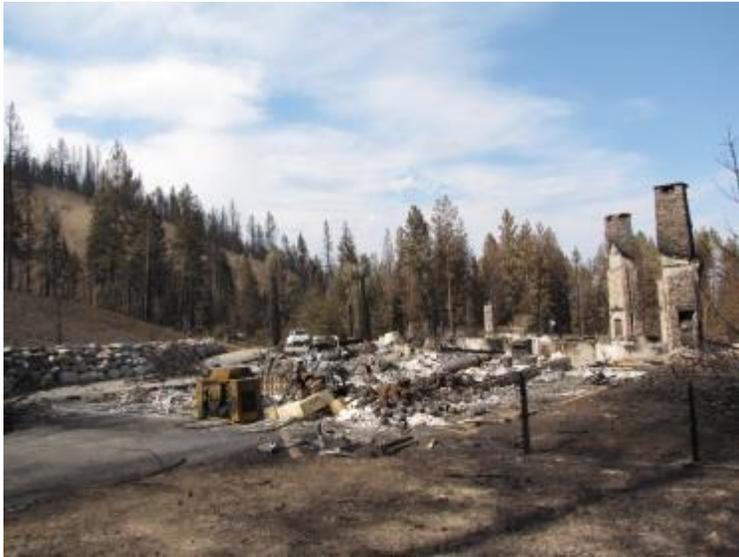
Site of landowner's house near the property boundary with the National Forest and Ownership #9 property. As seen in the left center of the photo, the fire burned with high intensity downslope to the east from left to right. It is anticipated that this home burned from the shower of embers, surface fire, and the intense superheated air from the crown fire.

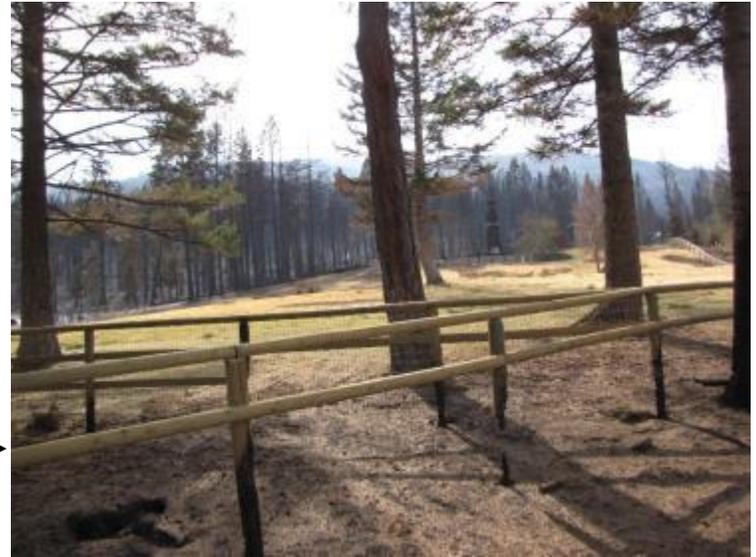
This photo shows the opening to the east of the home site that helped reduce the fire intensity below the house. Note the house chimney in the right center of the photo.

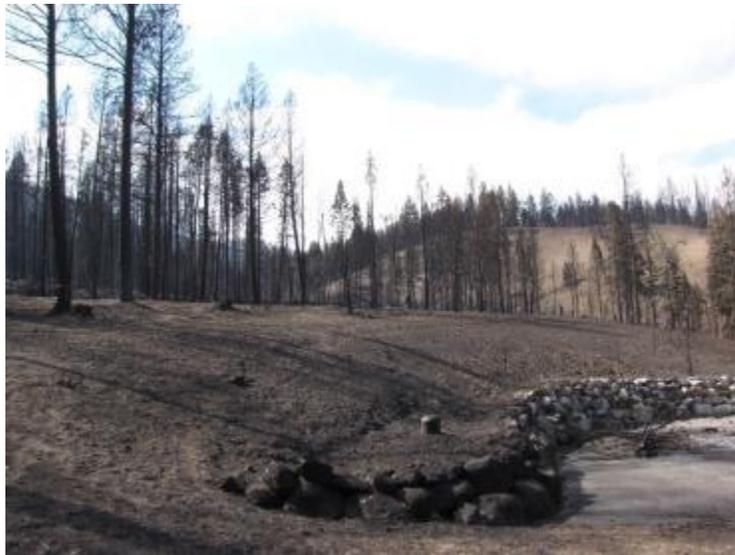
This photo shows the effects of the intense crown fire and space between the house and the surrounding timber to the west of the house adjacent to National Forest land. The house is to the right of the rock wall and the driveway. The rock wall can also be seen in the upper left photo.

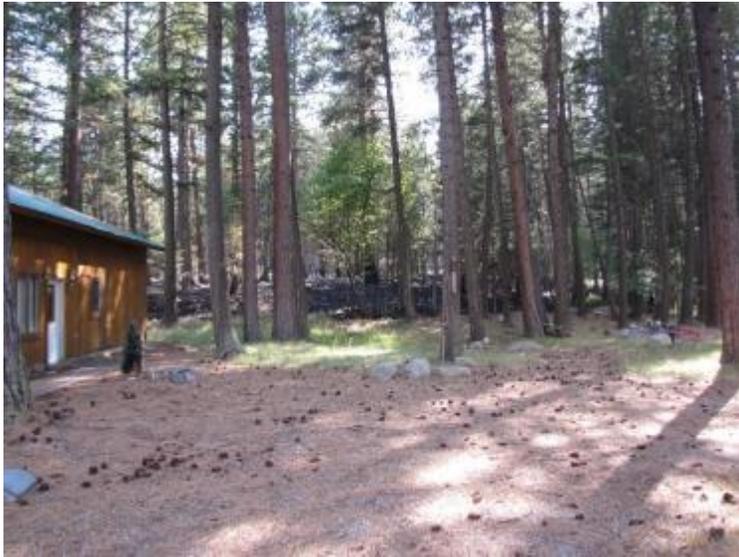
The fire burned as a low intensity surface fire around this secondary home. The surface fire stopped at an irrigation ditch that was running water. There was no evidence of any spot fires in the litter around the home.

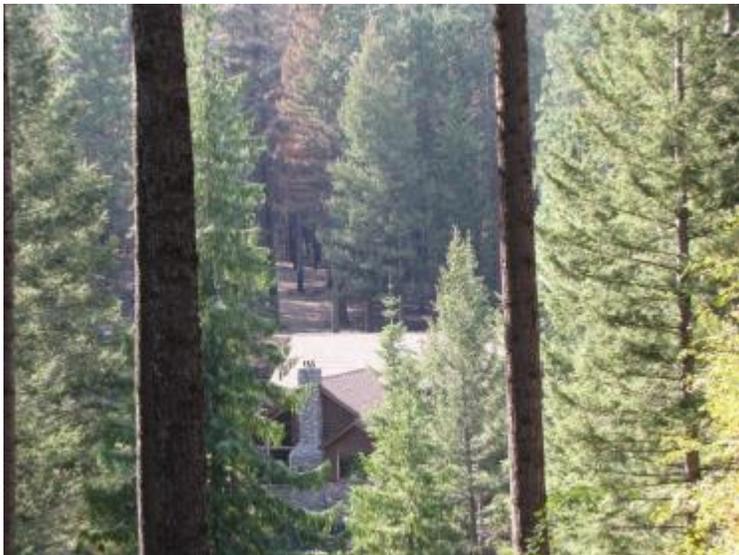
This photo shows the primary residence in the bottom of Roaring Lion Creek. This home was also not impacted by the fire.

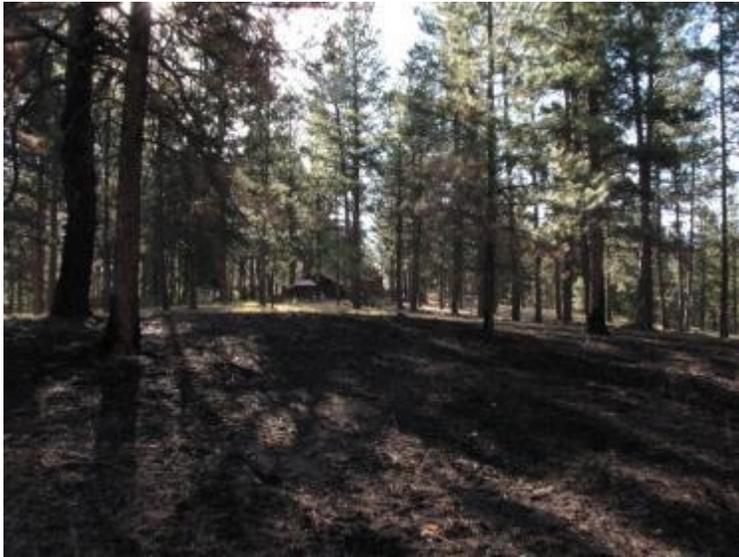
The burned area to the west of landowner's property was a surface fire that was controlled by a hand constructed fireline. The house can be seen in the middle of the photo. The brown cured grass between the house and burned area is where the fireline was located.

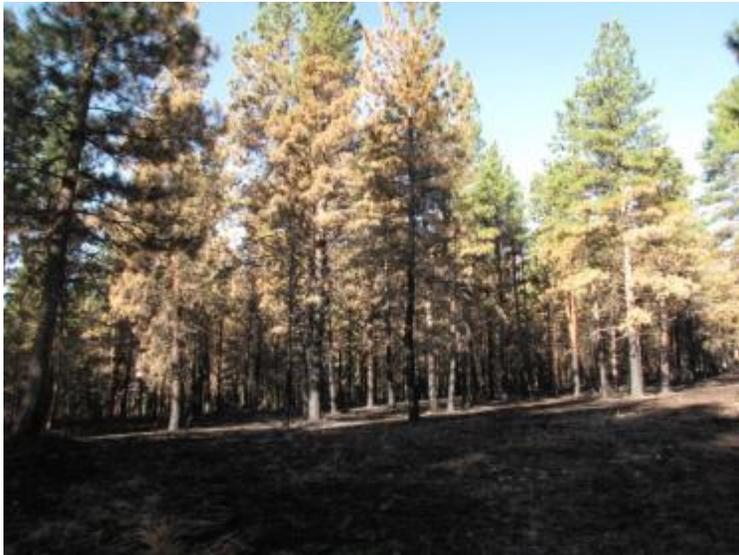
Severe scorch in the pine trees on the west side of landowner's property near the property boundary of the neighbor who lost their home in the upper right photo.

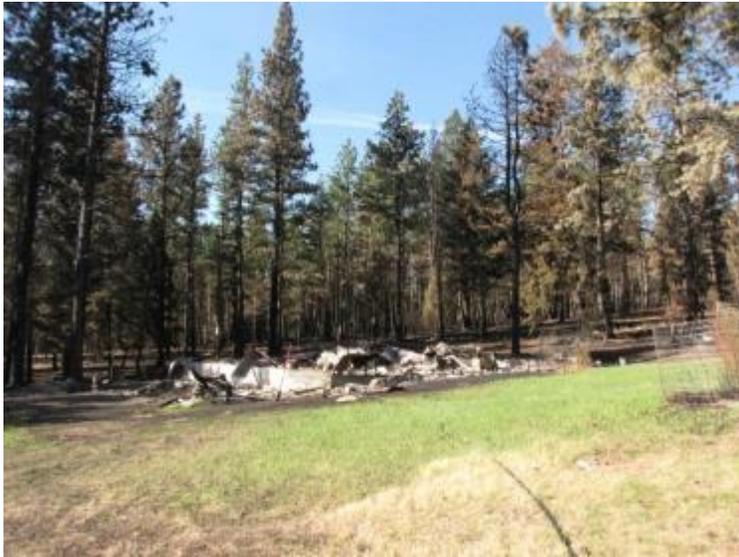
Landowner's home that was destroyed by the fire. It is anticipated that this home was burned due to the shower of embers, superheated air, and a surface fire burning up to the structure. The torched trees around the home site were torched from the heat of the burning home.

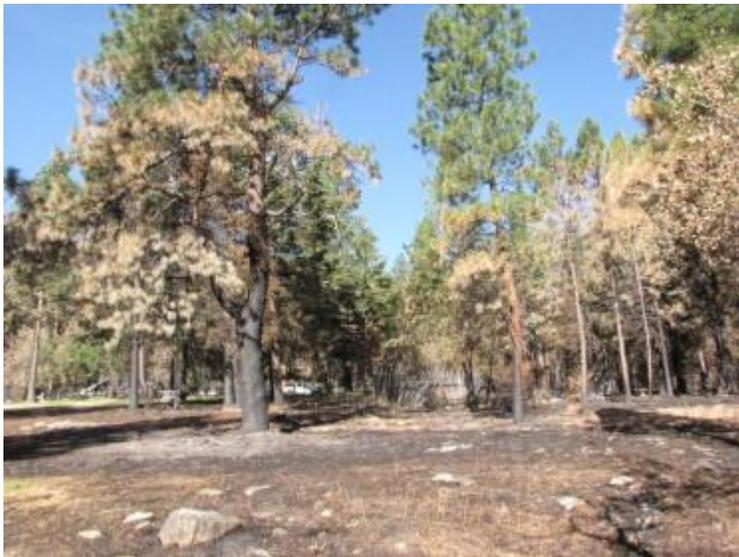
This area was burned due to the surface fire and the shower of embers starting spot fires within the stand of trees and in the openings in the cured grass and fine fuels.

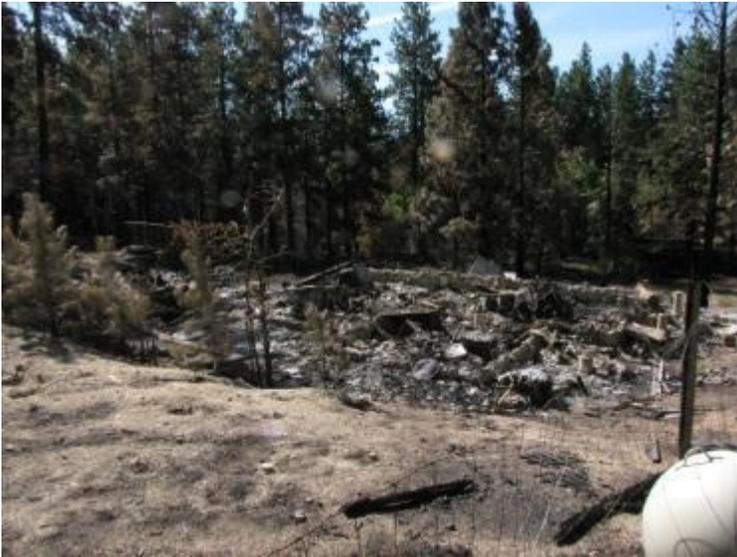
This photo is of the landowner home that was destroyed by the fire. The evidence points to this home being burned by the shower of embers landing on receptive fuels in and around the home as well as surface fire burning up to the home.

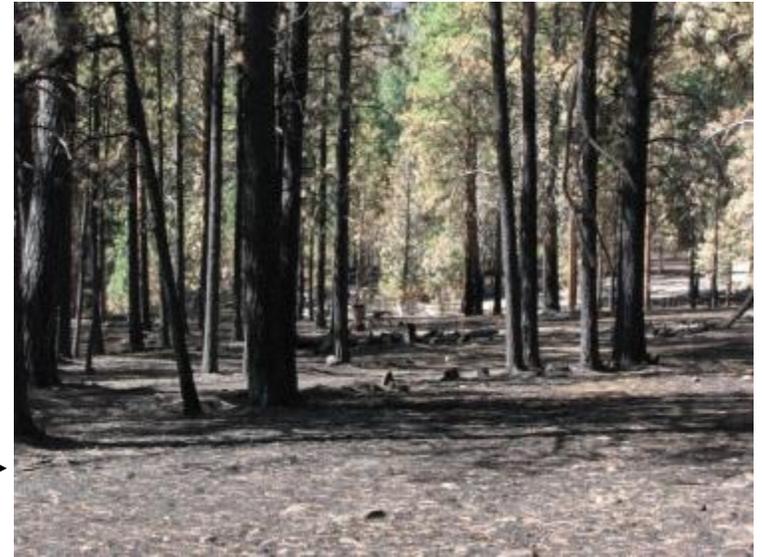
This area is within the thinned Ponderosa Pine stand to the north and upslope from the home. The fire that passed through this area was a surface fire.

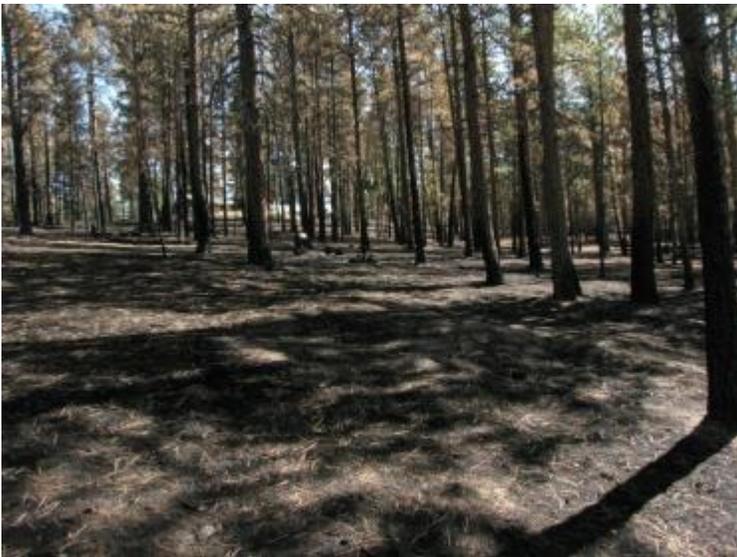
This is the thinned ponderosa pine stand to the north of the house that sustained moderate scorch from the intense surface fire. Virtually none of the trees allowed any torching due to the lack of ladder fuels.

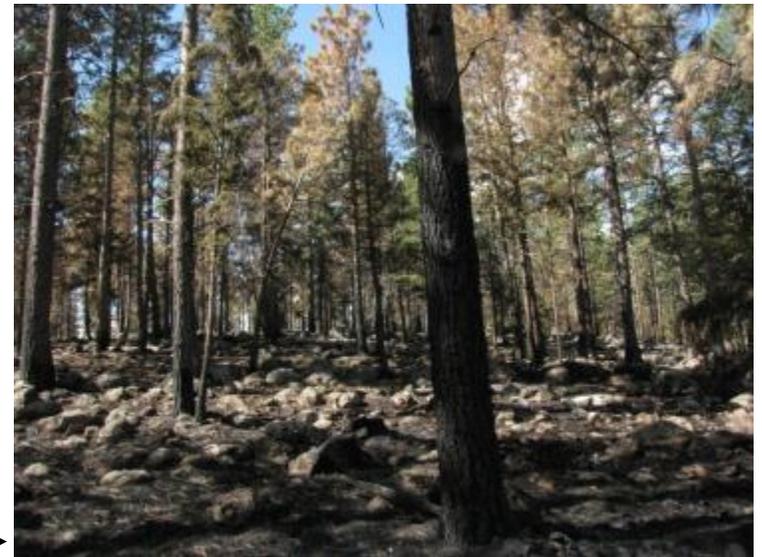
This is a stand of Doug-fir on the north aspect over the ridge to the north of the house near the property boundary. Most of the Doug-fir will probably not survive the surface fire even though much of the area had a tremendous amount of rock.

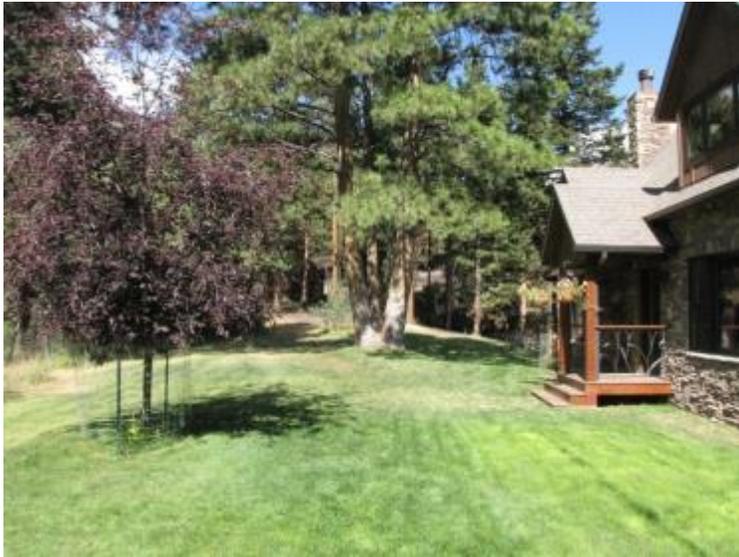
Landowner's home survived the fire due to its Firewise construction, the green lawn and excellent landscaping, and the thinning that was done near the home. \_\_\_\_\_

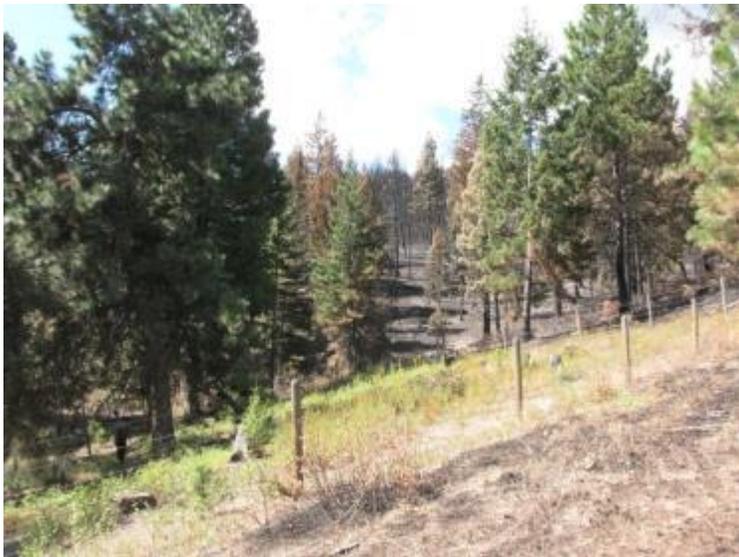
The area behind the fence did not burn even though there was an active crown fire in the background on NF land because this was a mule corral that had very little vegetation and very few trees. The area in the foreground was a surface fire that burned toward the barn. \_\_\_\_\_<

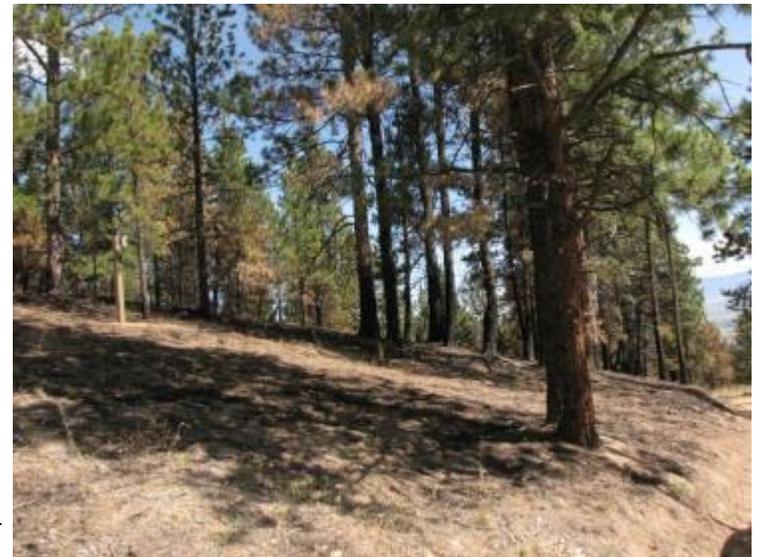
According to the landowner, this area to the east of the house is where the main fire spotted and then burned back to the west upslope and was being drawn by in-drafts from the main fire above the property on NF. This area underburned causing little damage to the ponderosa pines. \_\_\_\_\_>

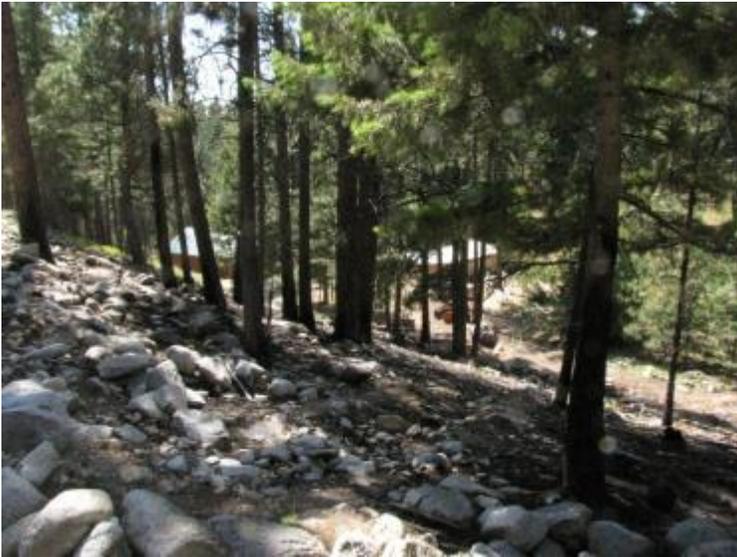
The area to the NW of landowner residence that underburned as a result of the low intensity surface fire. The fire only burned 1 to 1 ½ acres on this property and did not impact the structures. This area was thinned several years ago.

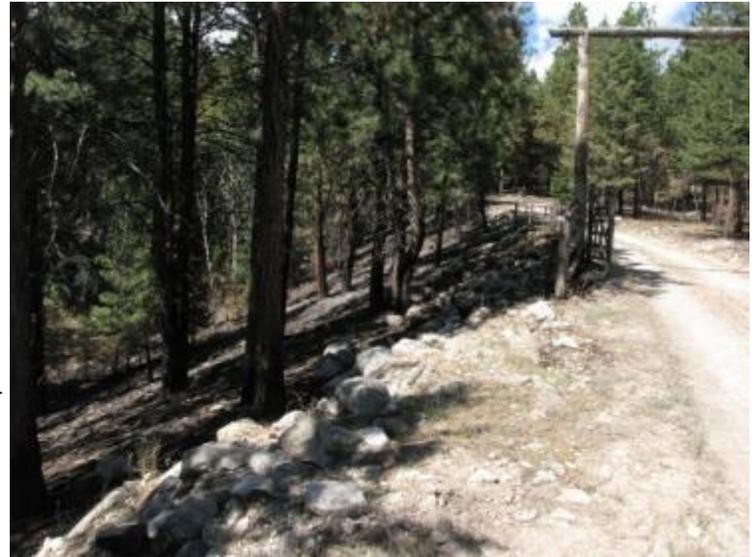
Another view of the same area that was a low intensity surface fire.

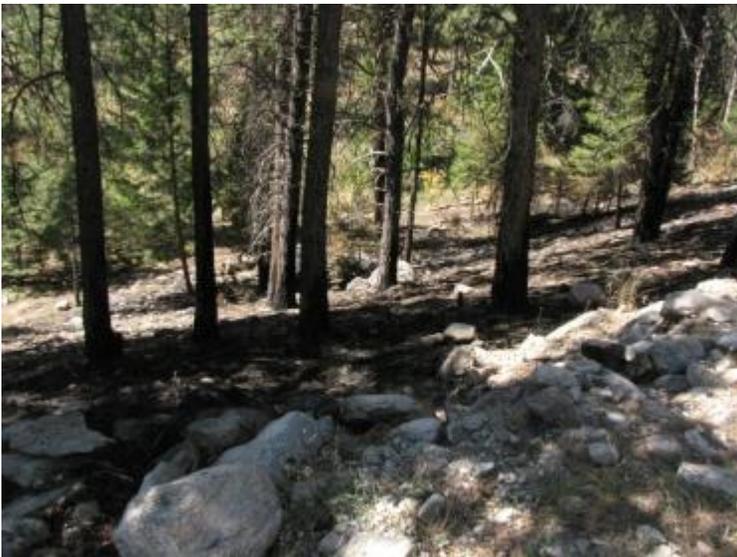
Same area where the surface fire burned but did not scorch any of the trees. Many of these trees were Doug-fir.

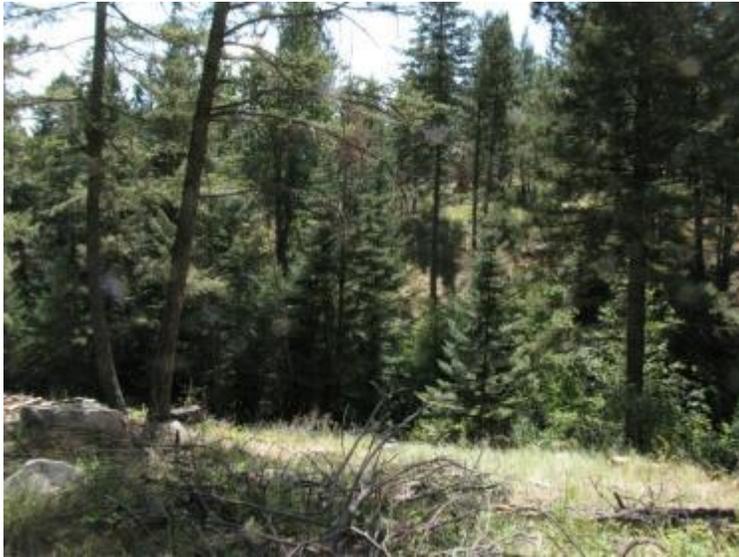
The landowner's home is located across the draw through the trees in the background. The riparian area did not burn in the fire. The fire burned the very north portion of the property through an area that was thinned.

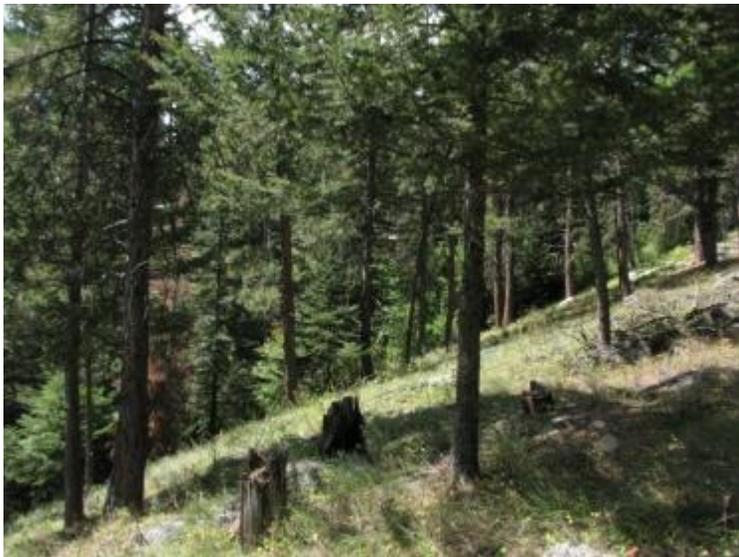
This is a photo of the thinned area north of the house and the draw. The fire did not burn into this area due to the lack of fuels and probably due to the wind conditions that were not spreading the fire in that direction. The adjacent property to the north of this area had an intense crown fire and torching which probably drew any fire spreading in the surface fuels by in-drafts away from this area.

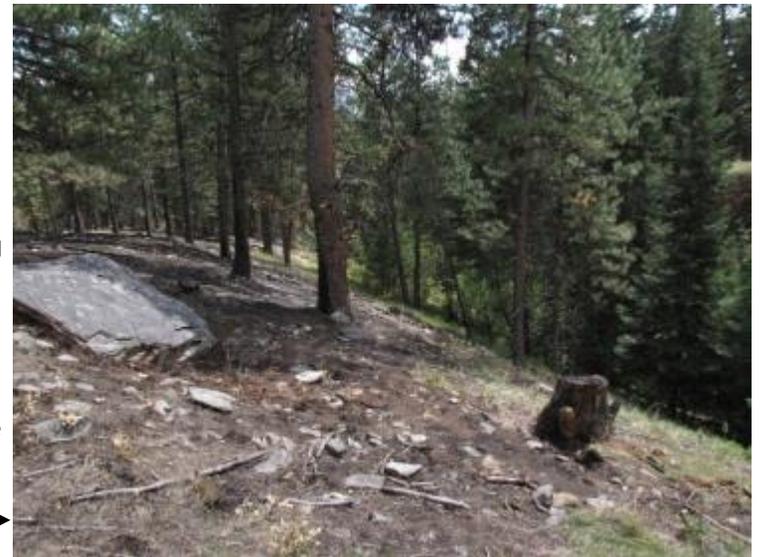
View of the fire that started burning down into the draw north of the house in the thinned area. This fire was stopped by a small scratch hand fire line.
