# Roaring Lion Fire - Assessment of Private Land Fuels Mitigation

Byron Bonney, Community Forester- Bitter Root RC&D

Visual assessment of hazardous fuels mitigation treatment following a wildfire event

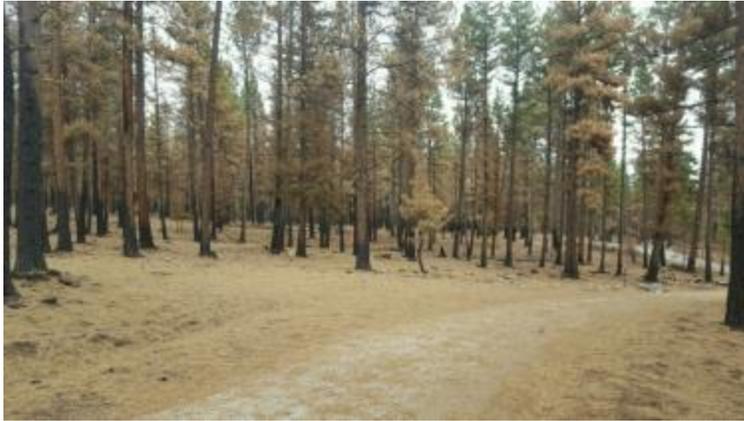
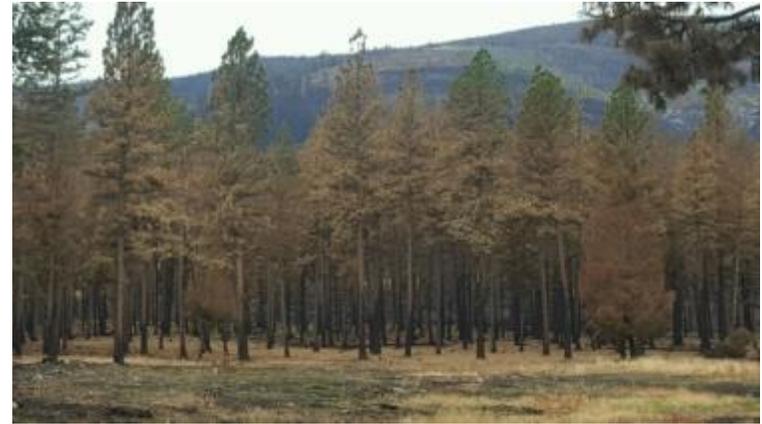
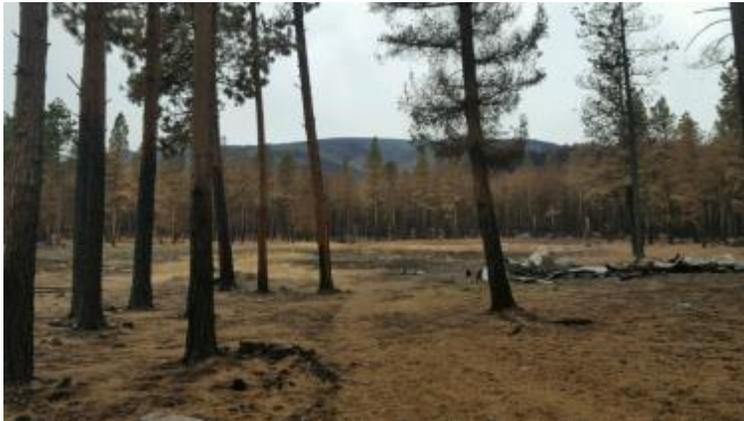
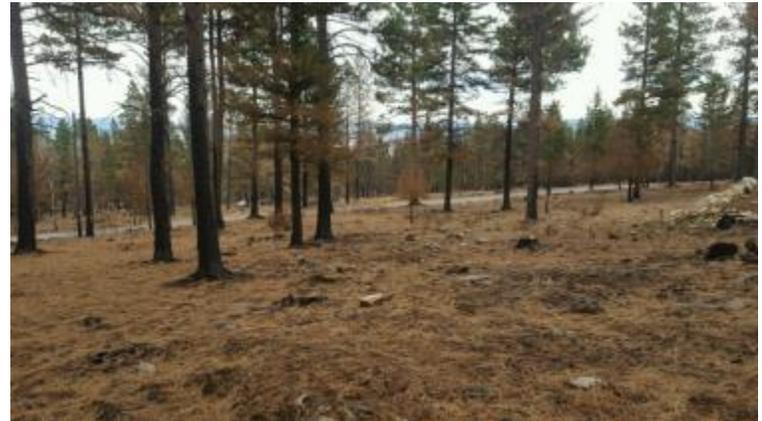
These four photos show the thinned stands on this property. Some severe scorch occurred from the superheated air passing through the stand. No torching or crown fire, only surface fire.

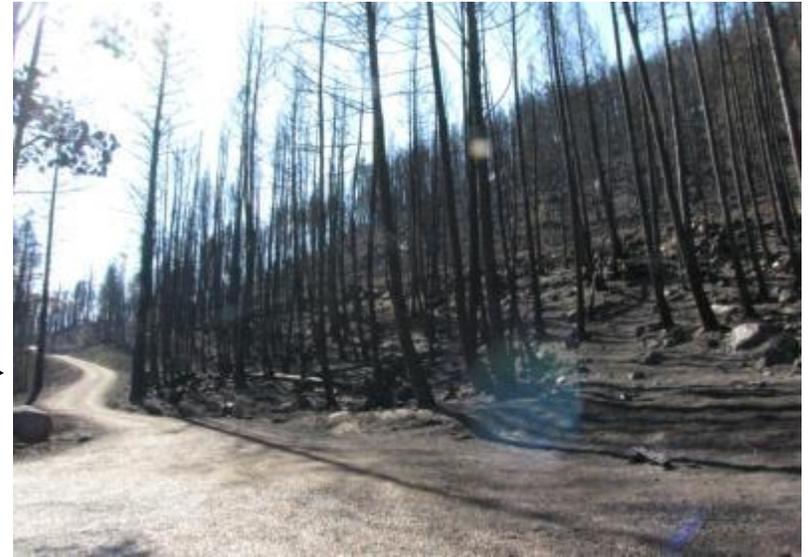
Looking SW across the Roaring Lion trailhead road through landowner's property to National Forest. Total stand replacement active crown fire.

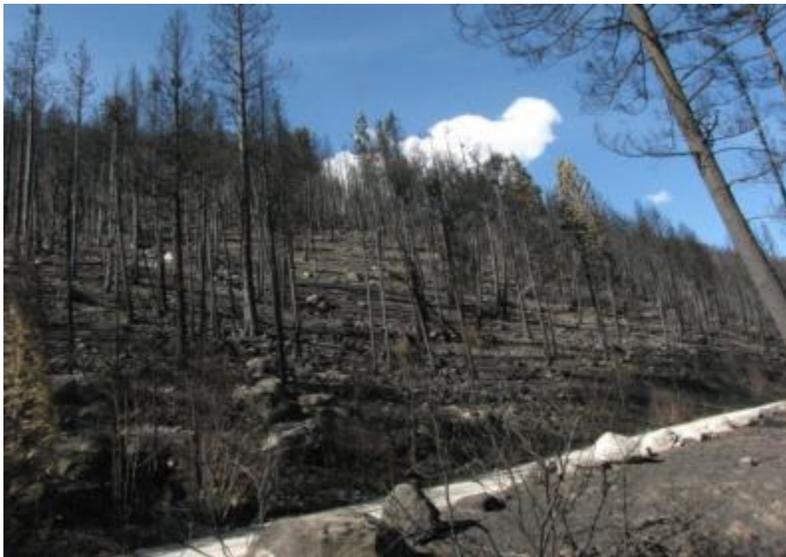
← Looking from Roaring Lion trailhead road down driveway toward where the house was destroyed. Opposite view from photo in upper right photo. →
